UTJECAJ VODOTOKA NA SIGURNOST MOSTOVA

Neven Kuspilić, Ph.D.

Gordon Gilja, Ph.D.

INFLUENCE OF WATERCOURSE FLOW ON BRIDGE SAFETY

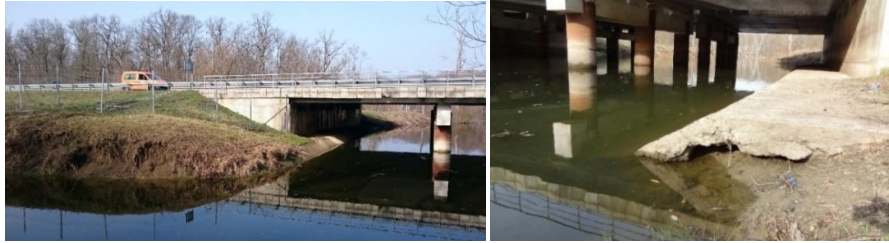
excavation and the collapse of their banks to the bed is registered at the confluence (Figure 3a). Figure 3. Collapse of the bank at the confluence of the collecting channel (left); a detail of the scoured concrete lining of the right bank (right).³

Figure 3. Collapse of the bank at the confluence of the collecting channel (left); a detail of the scoured concrete lining of the right bank (right).³

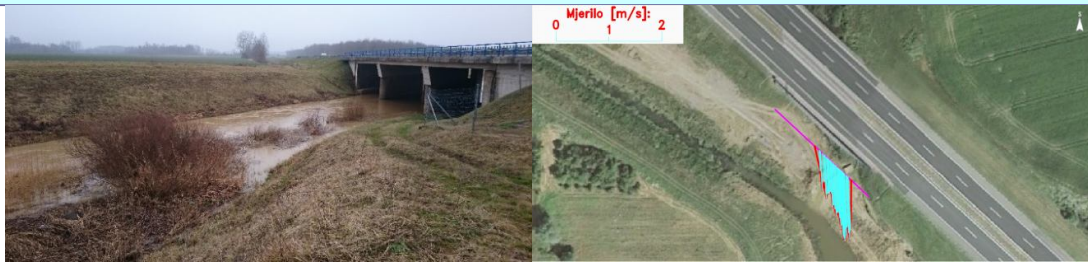
Velocities in the bed of the Lateral Channel are negligible (<0.27 m/s) in medium water conditions, while in high water conditions there is a significant increase in flow velocity in the bed upstream (0.72 m/s) and downstream from the bridge (0.55 m/s). In spite of the significant increase in flow velocity in relation to medium water conditions, there is no risk of global erosion since the allowable flow velocity ranges from 0.8 m/s to 1.2 m/s for the analyzed watercourse. Immediately upstream from the bridge, the service road passes through the bridge profile next to the right bank, and construction of its ramp in the bed has constricted the flow profile and directed a major part of flow towards the left bank (Figure 4a). It was calculated by the mathematical model that, in high water conditions on the thus constricted profile, the flow velocity locally reaches the value of threshold velocity for mobilizing the material from the bed (0.86 m/s), thus satisfying the conditions for occurrence of erosion due to constriction of flow in the bridge profile. This consequentially results in local increase of velocity in the left bridge opening and erosion of the bank (Figure 5a), as evidenced by comparison with the historical record. The bed erosion coincides with the location of the calculation profiles with increased hydraulic load on the bed, i.e. the erosion of the bottom of the bed in the bridge profile resulted from the constriction of flow. Sedimentation to the bed next to the right bank, which was subsequently covered by dense vegetation, was registered upstream from the ramp. Figure 4. Lateral Channel: a) constriction of flow profile upstream from the bridge, view from the right bank (left); b) inverted flow velocity profile on orthophoto map (right) Figure 5. Erosion due to constriction of flow in the left bridge opening (left); view of the scour hole next to the upstream face of the pier S1/15

Figure 4. Lateral Channel: a) constriction of flow profile upstream from the bridge, view from the right bank (left); b) inverted flow velocity profile on orthophoto map (right)4

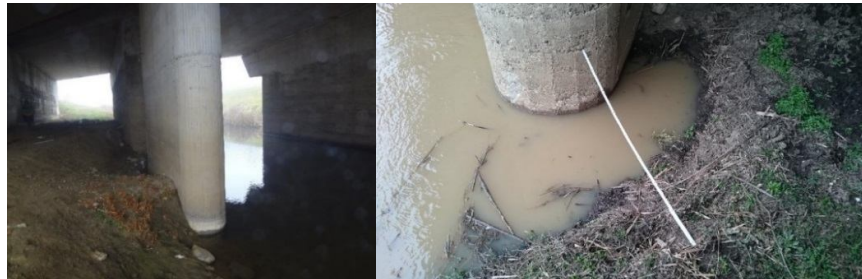
Using mathematical model, the potential local scour around bridge piers in the bed was calculated and it is $h_{E(LS)} = 0.54$ m for medium water conditions and $h_{E(LS)} = 1.14$ m for high water conditions. The measured depth of the local scour hole around bridge piers is 1 m, which corresponds to the effect of high water estimated by the model. The following figure (Figure 5b) shows the scour hole around the pier S1/1, as well as the erosion due to constriction of flow of the left bank (Figure 5a). Figure 5. Erosion due to constriction of flow in the left bridge opening (left); view of the scour hole next to the upstream face of the pier S1/15 Figure 5. Erosion due to constriction of flow in the left bridge opening (left); view of the scour hole next to the upstream face of the pier S1/15

Figure 5. Erosion due to constriction of flow in the left bridge opening (left); view of the scour hole next to the upstream face of the pier S1/15

The safety of piers undermined like this cannot be estimated because they are founded on "... footings of unknown foundation depth" [32], which makes it impossible to compare the scour hole depth with the actual depth of the foundation. The said detailed design also states that "... during geomechanical drilling, it was established that the bottom of the channel is about 85 cm deeper than anticipated by the channel design, which necessarily requires deeper foundation than planned by the conceptual design." This citation points to the possibility that the constructed foundations deviate from the design because of an adjustment to channel geometry.

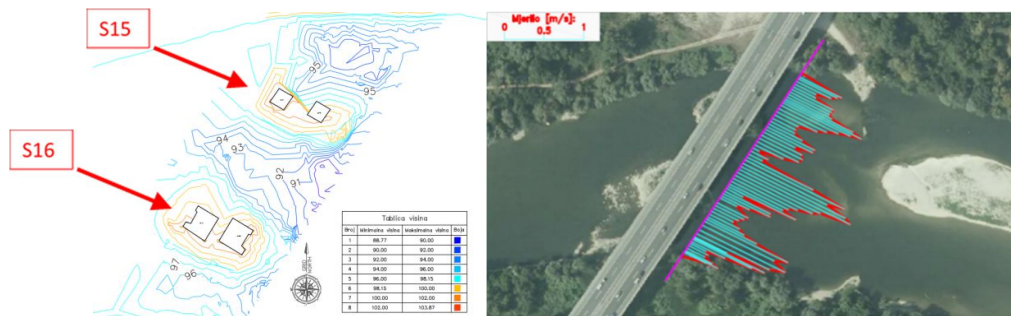
shows the rip-rap around the piers (Figure 6a), the construction of which has locally accelerated flow, intensified turbulence, and deepened the bed unprotected by rip-rap. In both the medium and high water flow conditions, the longitudinal velocity profile is uneven (Figure 6b)[30]. Figure 6. The Ivanja Reka bridge: a) detailed bathymetry of the bed in bridge profile (left); b) inverted flow velocity profile on orthophoto map (right) Figure 6. The Ivanja Reka bridge: a) detailed bathymetry of the bed in bridge profile (left); b) inverted flow velocity profile on orthophoto map (right)

Figure 6. The Ivanja Reka bridge: a) detailed bathymetry of the bed in bridge profile (left); b) inverted flow velocity profile on orthophoto map (right)

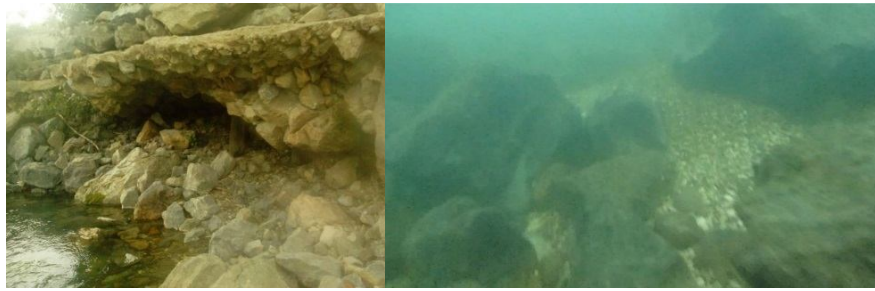
In addition to the construction of rip-rap around the piers, occurrence of these scour holes is also due to construction of the sill in the bed situated immediately upstream from the bridge. On the sill, the depth of flow decreases, which increases its velocity on the crown. As it passes over the crown, the flow shifts to forceful regime and hydraulic jump occurs in the bridge profile immediately downstream. In the hydraulic jump, the flow energy dissipates, affecting the gravel bed in the bridge profile, causing the bed material to move downstream and forming scour holes. This resulted in formation of a sandbank downstream of the bridge from the material eroded in the bridge profile (Figure 6b). The occurrence of scour holes in the bridge profile due to hydraulic jump is not localized only to the bridge profile. The scour holes between the piers S15 and the right bank and between the piers S15 and S16 continue downstream from the bridge profile, where they reach the maximum depth. The scour hole between the piers S15 and the right bank is 70 m away from the bridge axis and its depth is 11 m. The scour hole of the same depth is situated between the piers S15 and S16 at a distance of 40 m from the bridge axis, while the shallowest scour hole (8 m) is between the piers S16 and the left bank. The erosion of bed in the bridge profile has progressed to such an extent that edges of the scour holes have reached the toe of the rip-rap. Expansion of holes in this way caused scouring of the bed below the rip-rap and its collapse in the scour hole, which is most noticeable around the pier S15 (Figure 7). Figure 6. The Ivanja Reka bridge: a) detailed bathymetry of the bed in bridge profile (left); b) inverted flow velocity profile on orthophoto map (right) Figure 7. Detail of the collapsed rip-rap protection of piers S15: a) on the north slope (left); on the south slope (right)

Figure 7. Detail of the collapsed rip-rap protection of piers S15: a) on the north slope (left); on the south slope (right)7

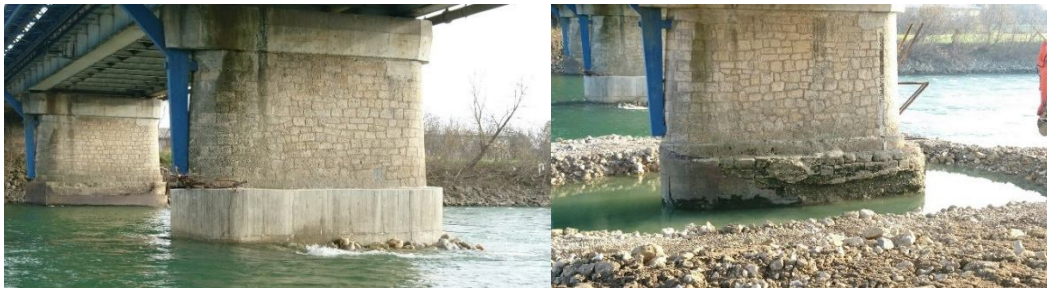
At the Podsused bridge, which has 3 piers in the main riverbed of the Sava River, the pier near the right bank is currently being repaired (Figure 8). All the degraded concrete of the pier foundation has been removed by hydrodemolition to sound concrete, and a total of 102 micropiles were drilled 3 to 4 m in depth around the pier foundation. Cement mortar is

Figure 8. View from the right bank of the Podsused bridge piers: a) previously repaired middle pier (left); b) right pier during repair (right)8

injected into the micropile holes at a pressure of 3 to 4 bar to fill the voids in the foundation soil and strengthen the body and foundation of the pier. Reinforced-concrete lining will be made around the pier foundation and all micropiles, and the bed will be protected against scour by crushed stone fill [33][34]. The middle pier of the bridge was already repaired using the same technology during 2014, 2015 and 2016, and it is also planned to repair the third bridge pier, near the left bank, for which bids are invited [26]. Figure 8. View from the right bank of the Podsused bridge piers: a) previously repaired middle pier (left); b) right pier during repair (right)8

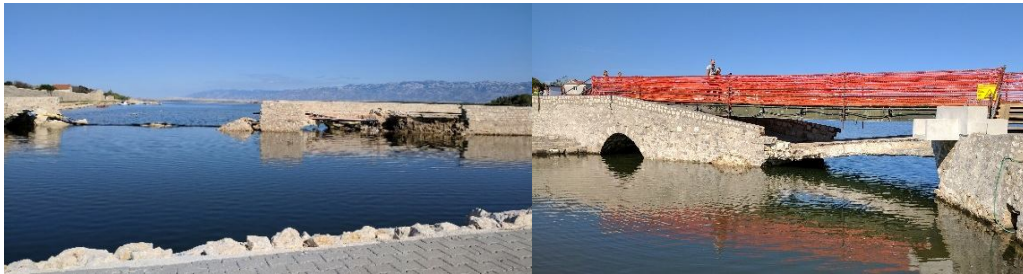
undermining their foundations (Figure 9). Figure 9. Bridges in Nin: a) the Upper Bridge (left); b) the Lower Bridge (right) / Author: D. Bujak9

Figure 9. Bridges in Nin: a) the Upper Bridge (left); b) the Lower Bridge (right) / Author: D. Bujak9

The stone bridges Lower Bridge and Upper Bridge were built on rock fill placed on a silty sea bottom of poor load-bearing capacity, with three stone arches with reinforcements on sections between arches with shallowly founded RC boxes. The exceptional cultural, historical and traffic significance of these bridges requires urgent repair of the damage and bids for execution of works are being invited. The works primarily involve stabilization of the foundation soil, construction of new foundations and static reinforcement of the structure. The stabilization of foundation soil is planned using the technology of jet-grouting of vertical piles at the site of collapsed bridge segments and using batter piles in the rock fill under the bridge foundation. The new foundation is planned using piles below foundations of arches,

topped with pile head beam and RC slab, which is also the bottom of bridge profile. Stone head walls are connected with RC boxes using steel anchors to reinforce the bridge structure while keeping the authentic historical appearance from the outside [38][39].

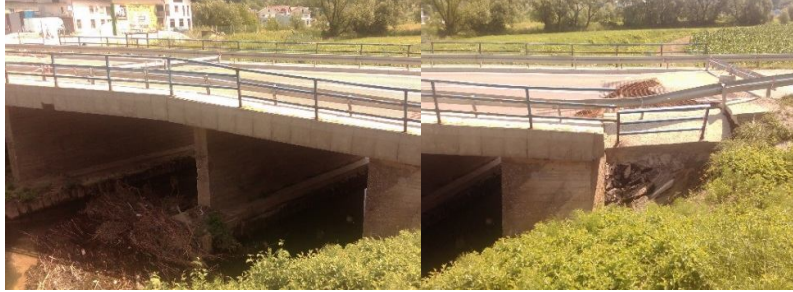
The Đurmanec bridge was built in 1969 on the state road D1 in Krapina-Zagorje County and is one of 1473 bridges in the state road infrastructure system [40]. During the high water event in June 2015, as a consequence of daily precipitation $> 23 \text{ l/m}^2$ in the Krapinica river basin, the flow through its riverbed had sufficient erosive capacity to erode the right bank next to the south abutment of the bridge. Along with the considerable flow of the Krapinica River, the floating sediment that accumulated in the central, largest, bridge span had an additional effect on the bank erosion. The amount of floating sediment (Figure 10) was sufficient to prevent flow through the central opening, but it was entirely directed to the right opening and it eroded the right bank behind the abutment 2-3 meters in depth as well as the abutment foundations, which resulted in its leaning [41]. The high erosive capacity of the Krapinica River in this place is the consequence of a large river bend just upstream from the bridge, which the river encounters after a long upstream straight stretch. Such sharp bends are typical of small rivers and channels over which roads are built, primarily because of the simplicity of structural design, however they have an exceptionally adverse effect on the water and sediment regimes, which is often manifested by erosion of banks and riverbed and occurrence of sandbanks near such bridges. Figure 10. The Đurmanec bridge: a) accumulated floating sediment in the central opening of the bridge (left); b) erosion of the bank behind the abutment (right) / Author: M. Skazlić10

Figure 10. The Đurmanec bridge: a) accumulated floating sediment in the central opening of the bridge (left); b) erosion of the bank behind the abutment (right) / Author: M. Skazlić10

The position of the bridge itself is very significant as it is located on a state road requiring regular traffic flow to be restored as soon as possible, and so the repair process was done in only forty days. In addition to the repair of the bridge structure, protection of watercourse bed was also performed by lining the bottom and slopes with 150-300 mm fraction crushed stone in concrete. Protection of slopes of both banks of the watercourse was carried out within the bridge profile and on the stretch of riverbed 10 meters upstream and downstream from the bridge [41].
