SIDE CUTS IN KARSTIFIED ROCKS ON THE EXAMPLE OF TWO PLATEAUS OF WF PODVELEŽJE

Amira Galić, Ph.D.

ZASJECI U OKRŠENIM STIJENAMA NA PRIMJERU DVA PLATOVA VE PODVELEŽJE

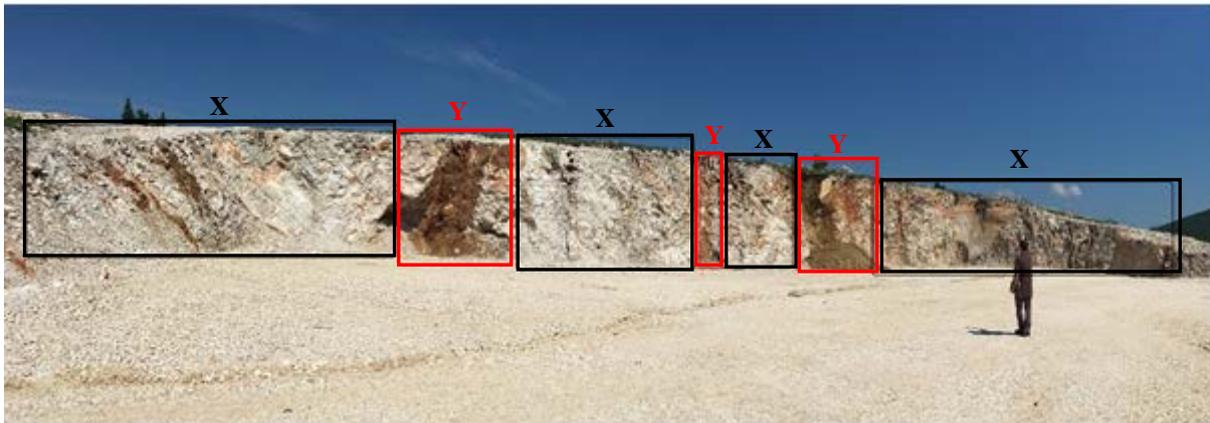
Plateau 9 is constructed partly in side cut, up to 9 m in height, and partly in embankment, up to 5 m in height. The excavation slope strike is 240/90. The excavation profile is divided into zones with similar characteristics, as shown in Figure 1. Four discontinuity systems are present in the rock mass and their description follows.

Figure 1. Plateau 9 with identified zones: X-rock mass of bedded to well-bedded limestones, Y-weakened zone, fault zone or highly karstified zone

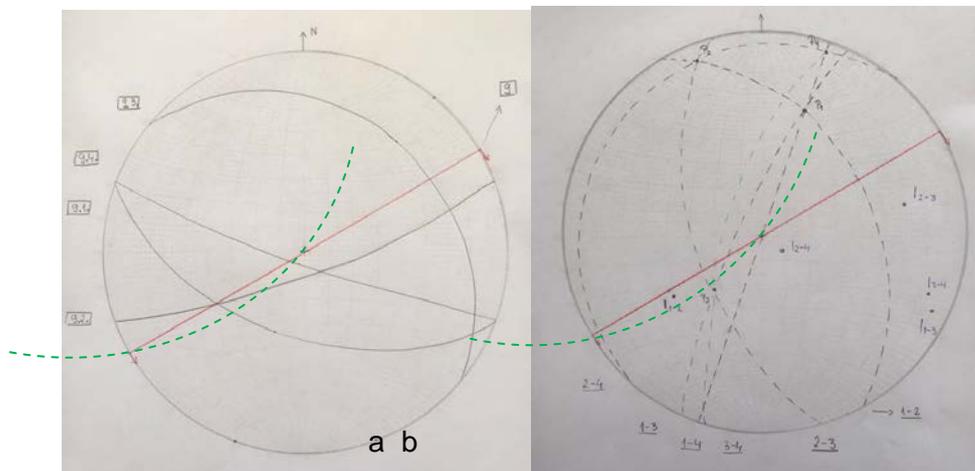
Figure 2. Kinematic discontinuity sliding analysis (a) kinematic wedge analysis (b) — vertical side cut; ---side cut at an angle of 60°

The kinematic slope stability analysis using stereographic projection of discontinuities in the plateau 9 area established that discontinuity sets 1 and 2 potentially jeopardize slope stability by their spatial orientation. The adverse effect of these discontinuities could be eliminated by reducing slope gradient by 30 degrees (green dashed line in Figure 2.a). The kinematic wedge sliding analysis shows that projections of all discontinuity plane intersections on the Schmidt diagram are before the excavation plane trace. This indicates that the spatial position of all wedges resulting from intersecting the discontinuities with excavation plane is very unfavorable for slope stability. Reducing the slope face gradient by 30 degrees would eliminate three groups of unfavorably oriented wedges (Figure 2.b). During investigations and classification of rock mass of the Plateau 9 area, trial boreholes were not carried out, so the rock quality designation was done according to the volumetric joint count (Miščević, 2015):

Four discontinuity systems are registered on plateau 9. Kinematic analysis of their spatial position identified two out of four discontinuity systems that potentially jeopardize stability of the vertical excavation. However, this adverse effect of discontinuity spatial orientation is significantly reduced if the side cut gradient is reduced by 30°. Reducing the side cut gradient also reduces the possibility of forming potentially unstable wedges. In case of a slope at an angle of 60°, the RMR_{89} classification shows that the rock category would change from very poor (V) to poor to fair (IV-III).

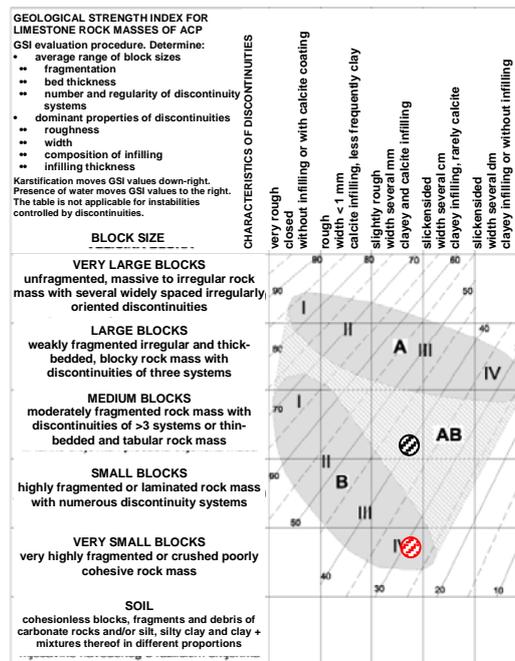
Figure 3. GSI classification of rocks mass in side cut of plateau 9 (⊗-X zones; ⊗-Y zones)

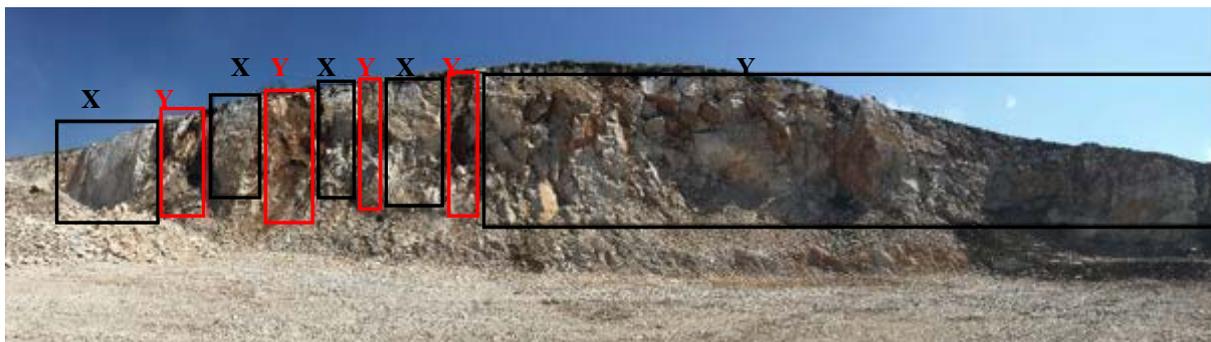
Plateau 14 is constructed partly in side cut, up to 11 m in height, and partly in embankment, up to 6 m in height. The excavation slope strike is 270/90. The engineering geological model is adjusted to the description developed by Pollak (2009), i.e., to his model with five weathering zones and it is the same as on the previously described plateau 9. Three discontinuity systems are registered.

Figure 4. Plateau 14 with identified zones: X-rock mass of bedded to well-bedded limestones, Y-weakened zone, fault zone or highly karstified zone

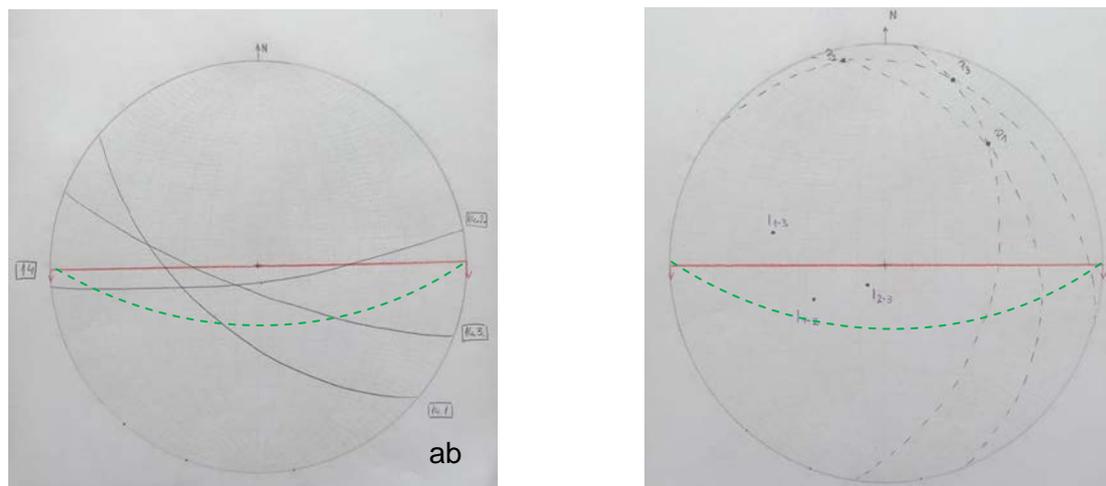
Figure 5. Kinematic analysis of three discontinuity sets (a) and kinematic wedge stability analysis (b) in the area of plateau 14 (— vertical excavation; ---excavation with dip 75°)

The kinematic slope stability analysis using stereographic projection of discontinuities in the plateau 14 area established that all three discontinuity sets potentially jeopardize slope stability, because their traces are mostly before the slope face. Changing the slope face gradient by 25 degrees would eliminate their adverse effect (Figure 5.a). Kinematic wedge sliding analysis shows two groups of potentially unstable wedges. Reducing the slope face gradient by 25 degrees would eliminate their adverse effect.

Three discontinuity systems are registered on plateau 14. Kinematic stability analysis showed that the unfavorable spatial relation between the discontinuities and the side cut face can be significantly mitigated if the side cut is performed at an angle of 65°. The results of RMR_{89} classification at this angle of side cut showed a change of the category from very poor to poor (V-IV) to fair (III).

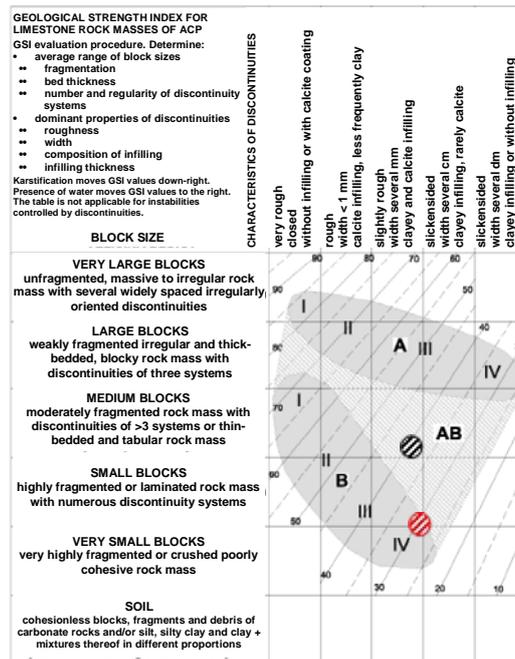
Figure 6. GSI classification of rocks mass in side cut of plateau 14 (⊗ -X zones; ⊗ -Y zones)
