THE CRACKS ON THE OLD BRIDGE IN MOSTAR

Abstract: The Old Bridge in Mostar was restored in mid-2004. The first cracks were observed in 2007. The cracking process has been ongoing since then. This paper presents the process of cracking and comments on the vertical deflection of measurement points on the bridge since construction of the new bridge. The analysis of these phenomena has been carried out and some possible causes of their emergence have been addressed.

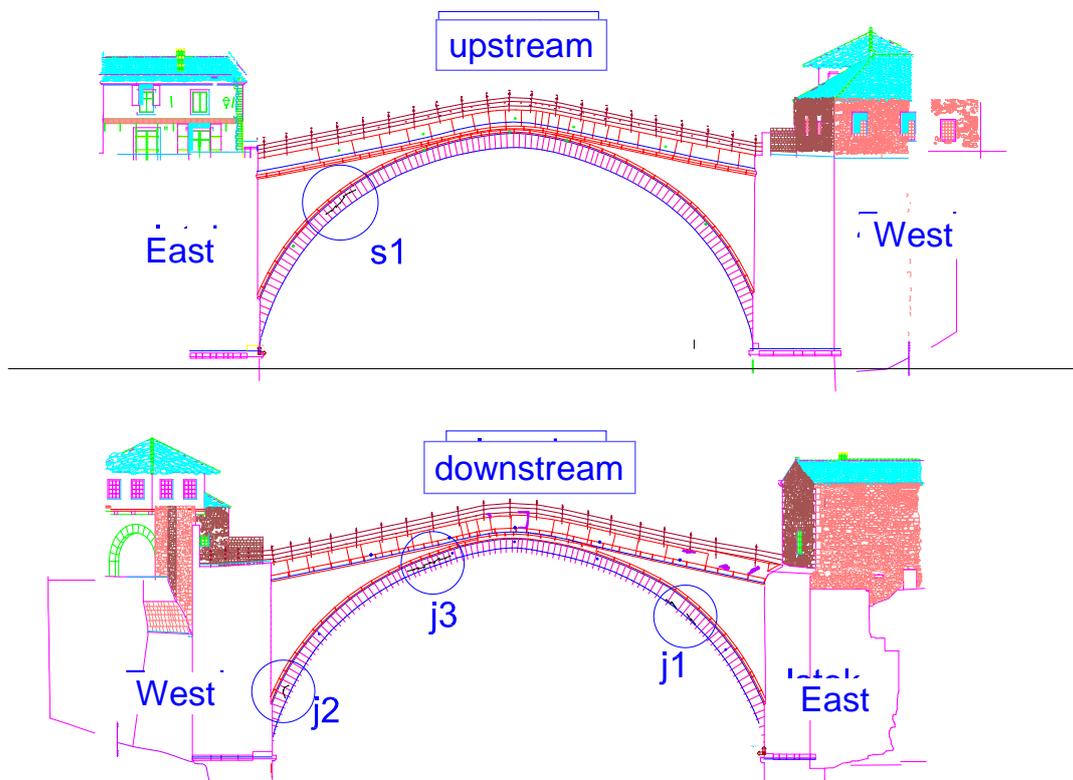
Cracks were observed on the arch of the Old Bridge in Mostar at the end of November 2007. Significant cracks were observed in several places on the bridge arch. They were found on the north and south sides of the stone arch on the east bank of the bridge at about half the arch height (S1 and J1), while on the west bank cracks were only on the south side of the bridge arch at one fifth of the arch height (J2). Also, on the south side there were cracks slightly lower than the arch crown towards the west bank (J3)(1). Cracks were not observed on the intrados of the bridge. All the cracks extend over several stone blocks of the arch and do not go only over joints.

Figure 1. Cracks from 2008 (1)

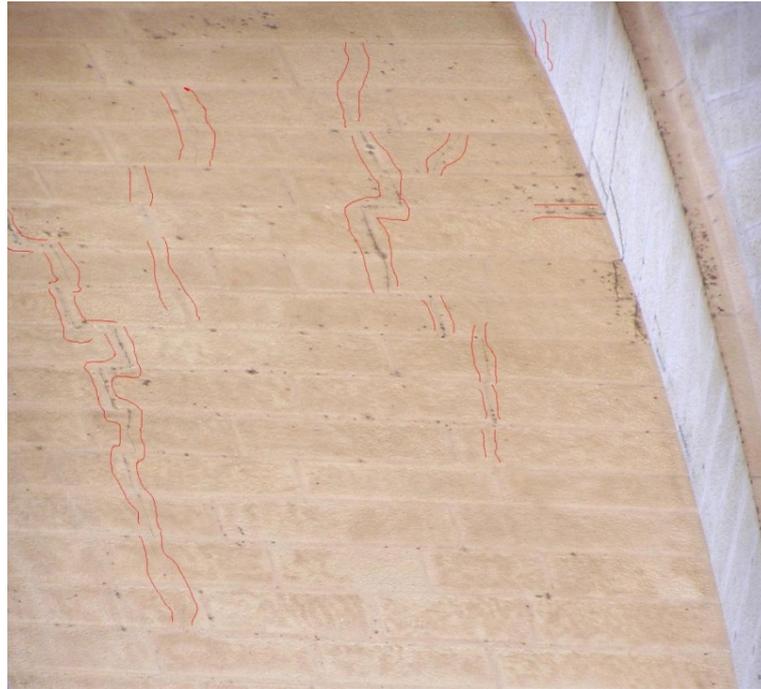
In the next several years, cracks on the bridge were distributed on a larger area of the bridge arch, and already in 2008 they also appeared on the intrados of the bridge. In mid-2010, a spatial recording of the bridge was carried out and a drawing of cracks on the intrados of the bridge vault was made (3).

Figure 2. Cracks on the bridge intrados on 9 November 2008.

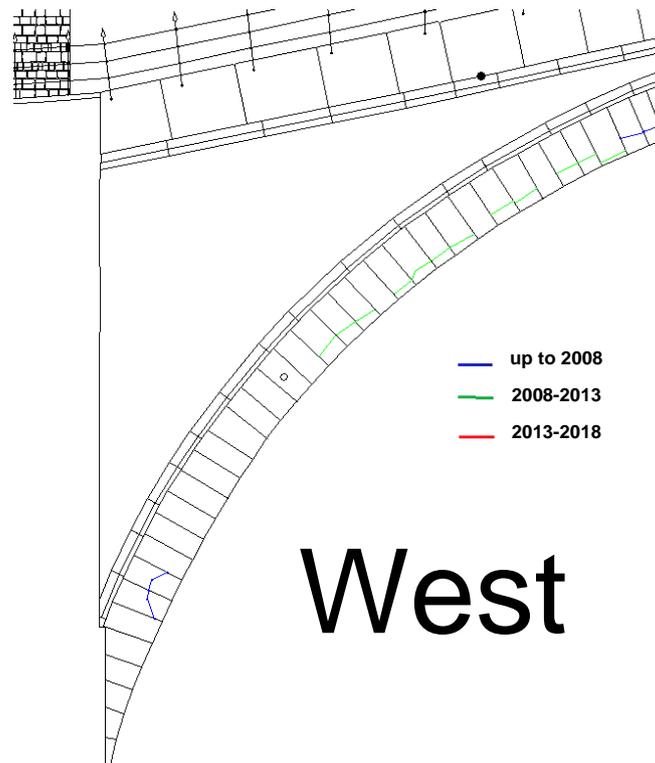
Figure 3. A sketch of the cracks on the downstream side of the bridge arch - west

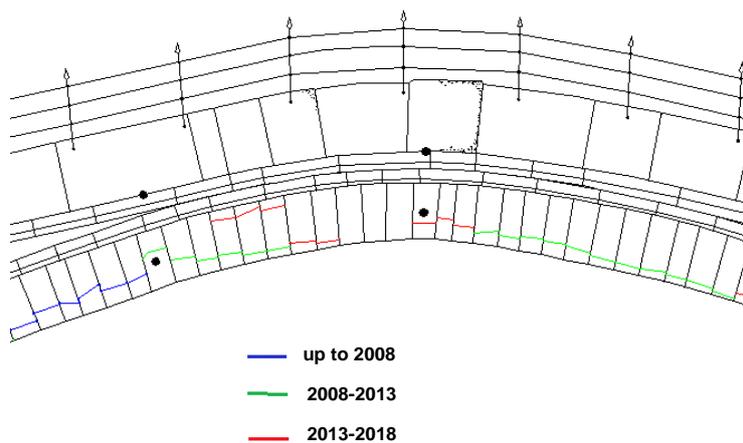
Figure 4. A sketch of the cracks on the downstream side of the bridge arch - center

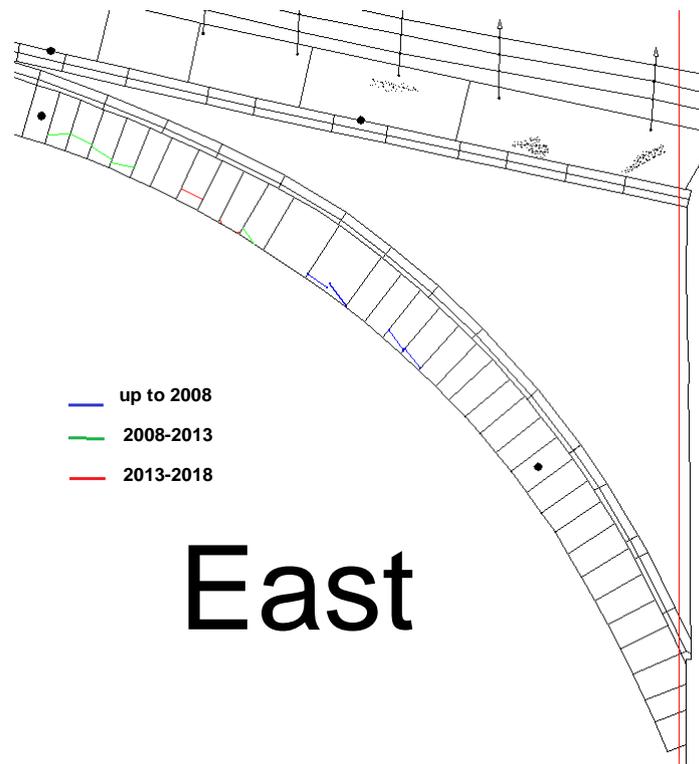
Figure 5. A sketch of the cracks on the downstream side of the bridge arch – east

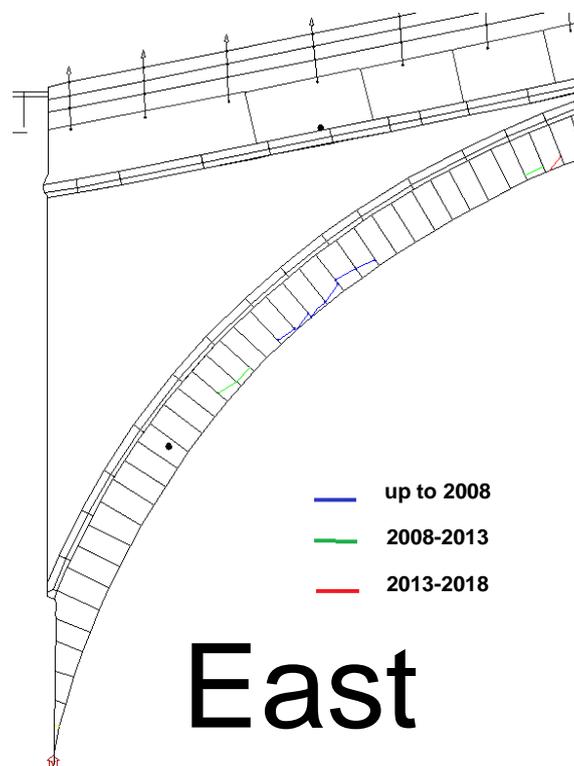
Figure 6. A sketch of the cracks on the upstream side of the bridge arch - east

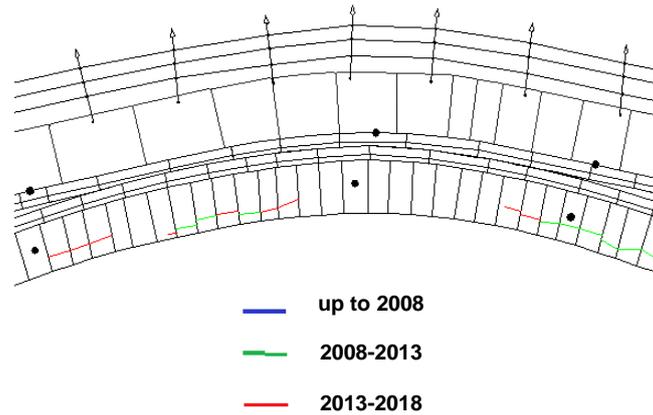
Figure 7. A sketch of the cracks on the upstream side of the bridge arch - center

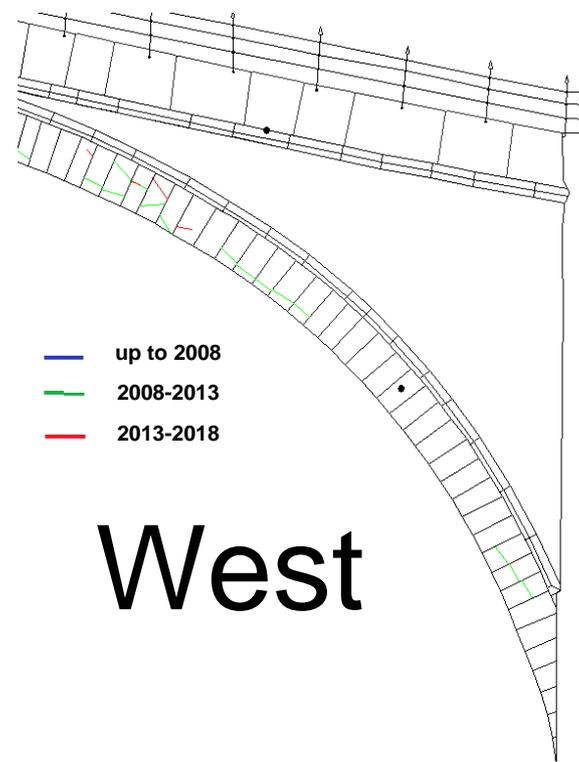
Figure 8. A sketch of the cracks on the upstream side of the bridge arch - west

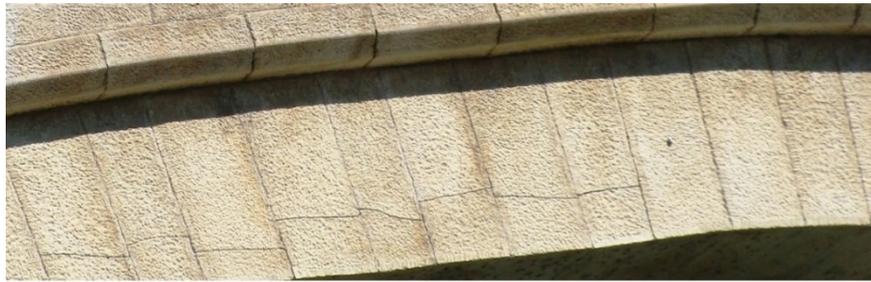
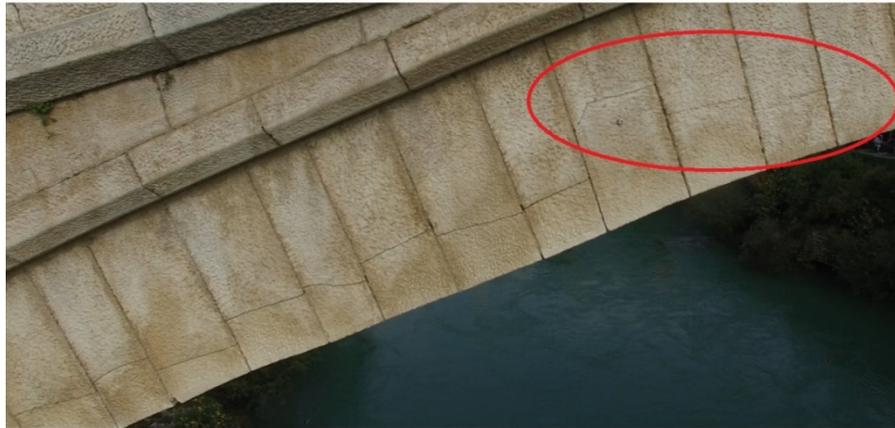
The period of development of new cracks from the photograph in the spring of 2018 to the recent photographs in early December is particularly interesting. A significant number of new cracks appeared on sides of the bridge vault in this half-year period.

Figure 9. Cracks on the downstream side of the arch from 2013 and 2018. Visible new cracks to the right of the benchmark

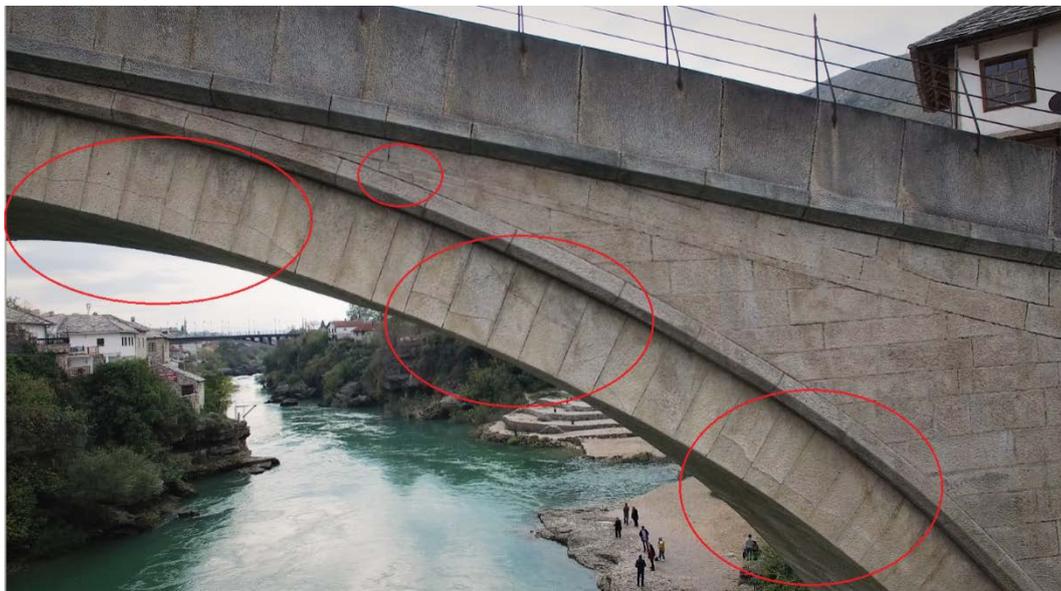
Figure 10. Cracks on the upstream side of the arch in 2018

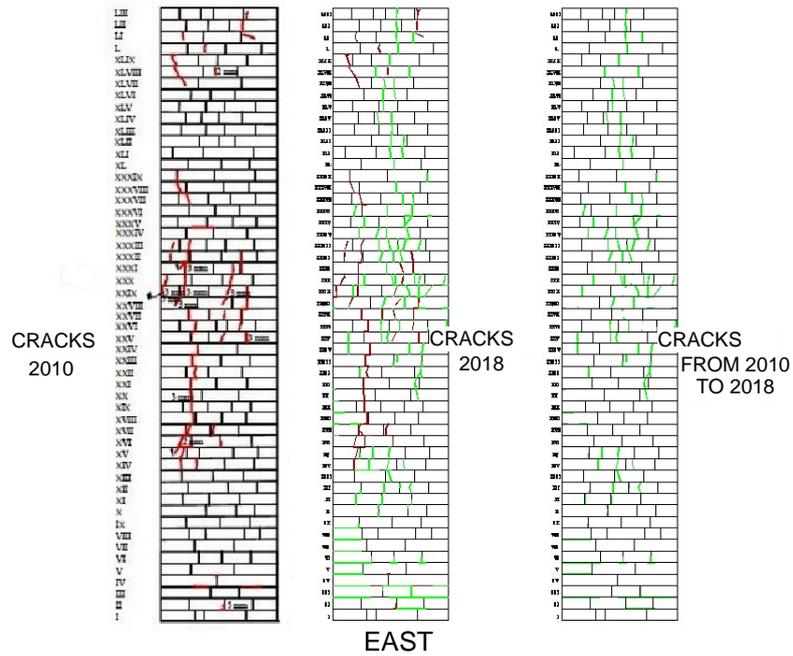
Figure 11. A sketch of the cracks of the bridge vault intrados towards the east side

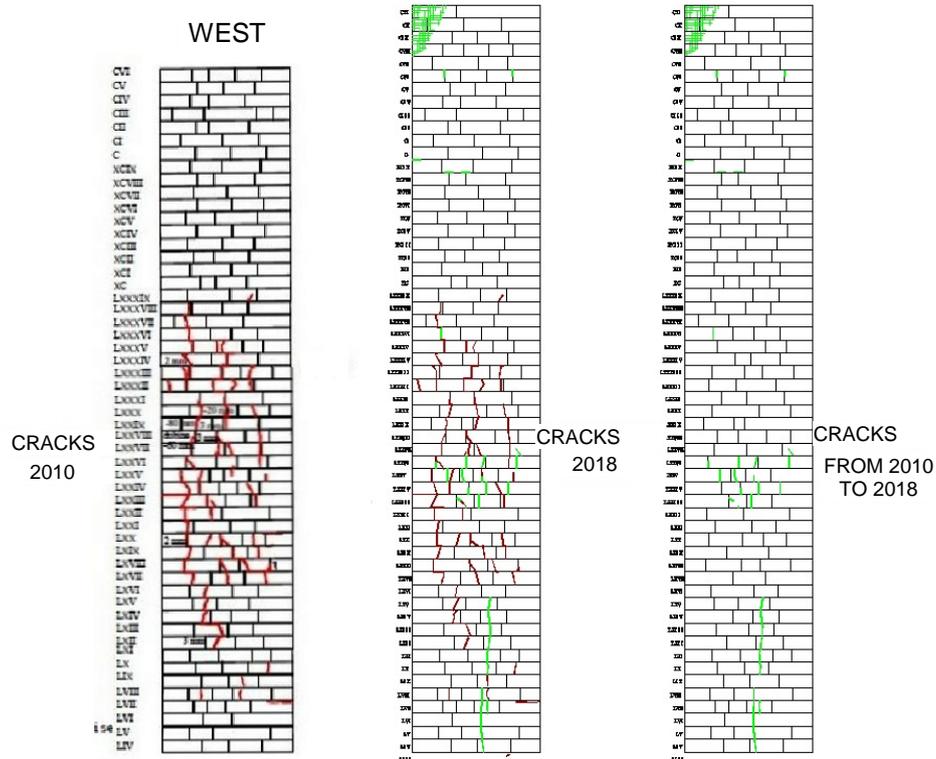
Figure 12. A sketch of the cracks of the bridge vault intrados towards the west side

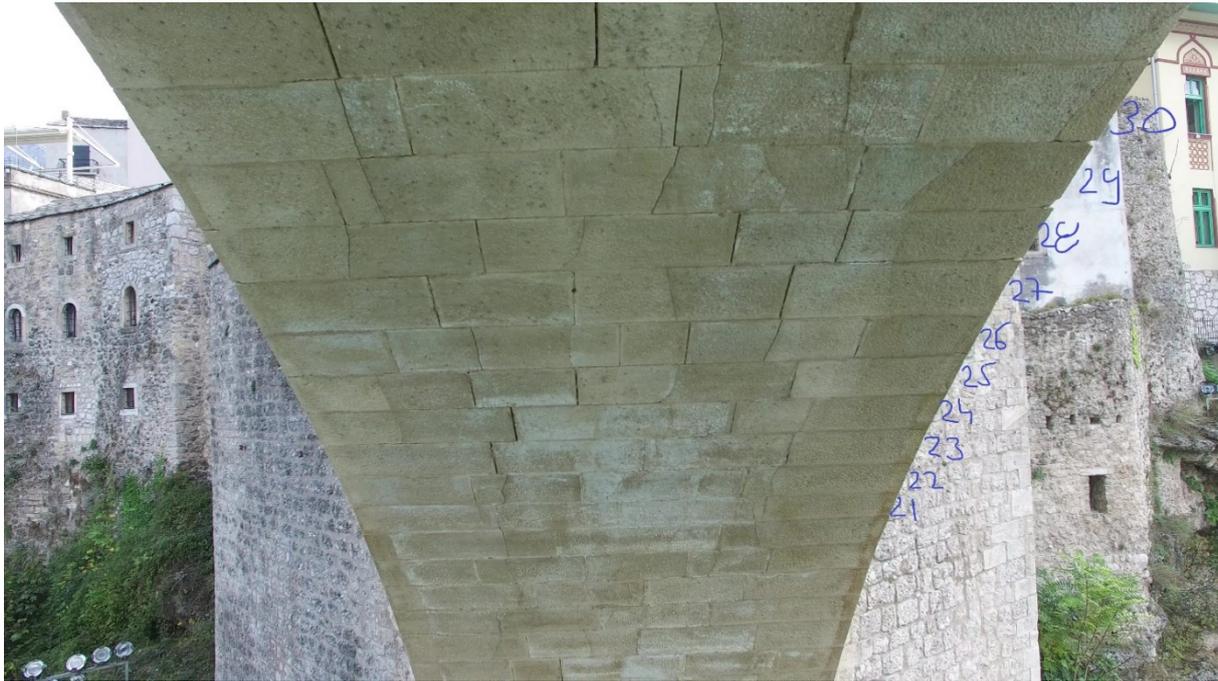
Figure 13. Cracks on the bridge intrados east side, 2018

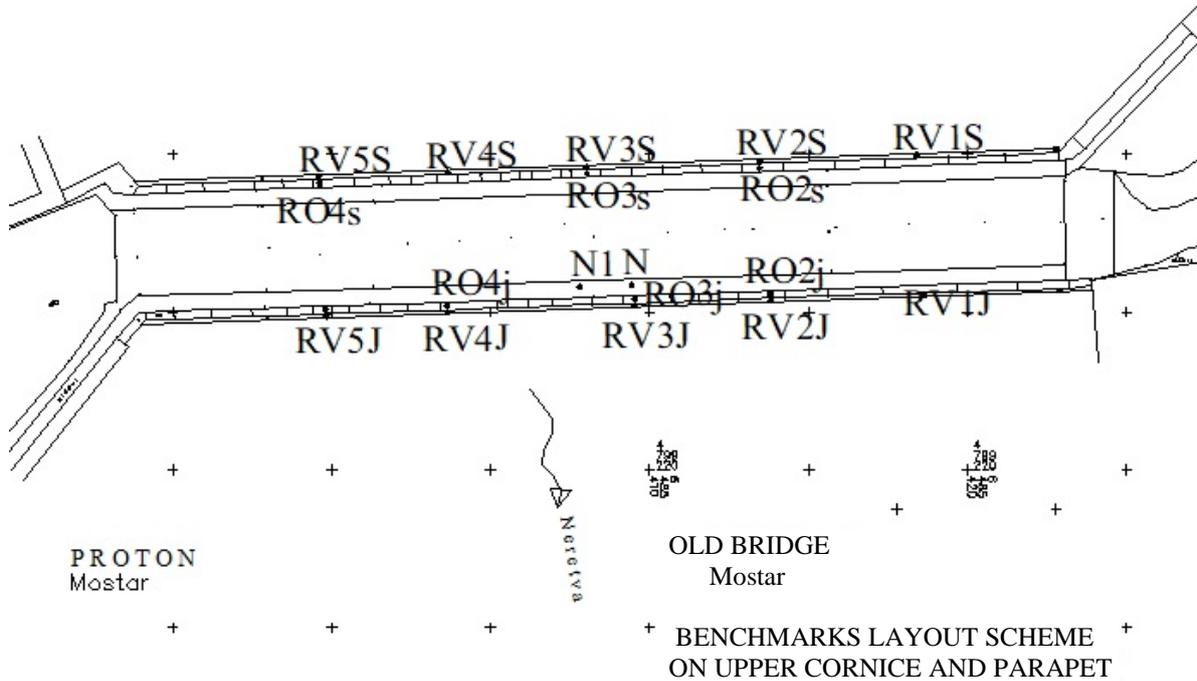
Figure 14. Positions of benchmark points

Analysis of the deformation values shows that the values at the benchmark points RV3 (bridge center) increase upward (negative deflection) as time passes, while the values at the benchmark points RV1 and RV5 increase negatively (deflection). These increases in absolute deformation values appear both in winter and summer measurements. Absolute elevation values of the benchmark points RV3 in the summer are greater than the winter ones, while it is the opposite for the outlying benchmark points RV1 and RV5.
