## Durability of freshwater limestones *tenelija*, *miljevina* and *muljika* - Built-in factors as causes of changes in the stone

Krešimir Šaravanja

Franjo Oreč

**Abstract:** This paper presents the freshwater limestones, from *tenelija* and (*Mostar*) *miljevina*, which are intercalated in the Mukoša deposit near Mostar, and their "stone cousins," *Posušje miljevina* and *Tomislavgrad muljika*. In the process of diagenesis they acquired a specific orientation and structure (especially *tenelija*), which gave them specific physical properties (small bulk density, high porosity and permeability), which "classic" limestones used in construction do not have, and which were decisive for the choice of this stone for construction of the Old Bridge and other buildings in the wider area of Mostar and in the area of Posušje municipality, but also in other karst poljes of Herzegovina and southwestern Bosnia, in parts of Central Bosnia, and *Miljevina* near Foča. The second part of the paper presents the so-called built-in (internal) factors that the builders try to avoid in order for freshwater limestones that are built into numerous stone buildings and/or monuments to avoid complex proce

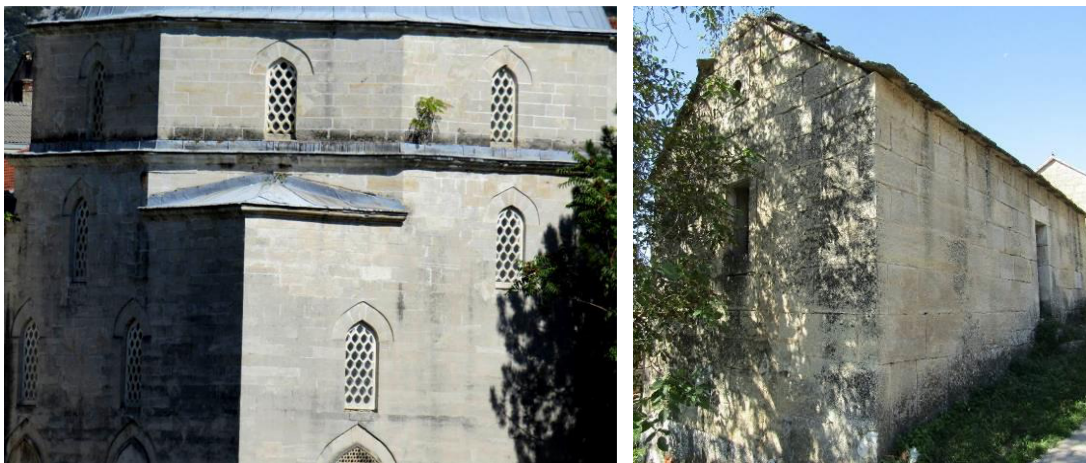
Figure 9-10. The different appearance of the surface of the shaded parts on the west side of the reconstructed Koski Mehmed Pasha mosque in Mostar in relation to the sunnier south side; The stone facades are built of tenelija stone covered with surface deposits of dirt, the formation of which is caused by a combination of factors related to pollution and the effect of moisture on the stone (left); The different appearance of the surface of the stone facade of the shaded eastern and northern sides of the house in Tomića Brig-Vinjani near Posušje, built of miljevina, as a consequence of its location (right); The patina is also more pronounced in the parts closer to the ground, and around the gutters due to longer retention of water, (photo: K. Šaravanja), [6]

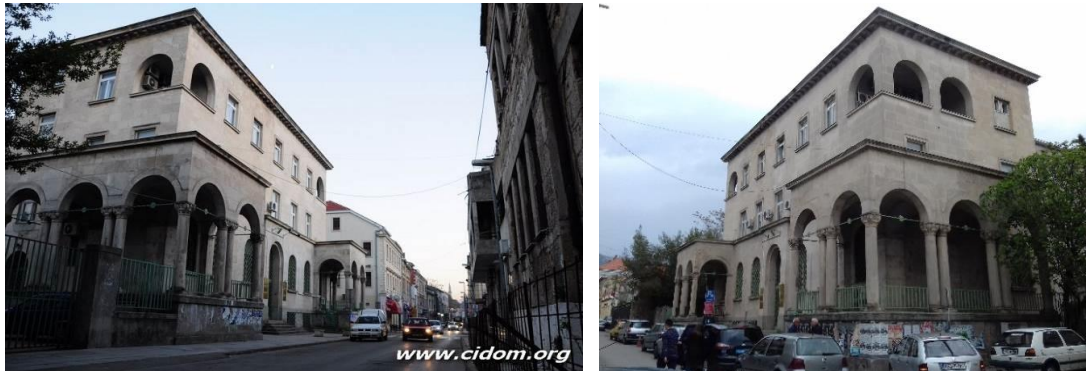
Figure 11-12. The lower part of the stone northwestern facade of the former SDK building in Mostar (left, [www.cidom.org](http://www.cidom.org)) is more markedly covered with surface deposits of dirt than the southwestern part of the facade (right); The formation of these deposits is caused by a combination of factors related to air pollution (from traffic, heating of households and industry) and the effect of moisture on stone, (photo: K. Šaravanja), [6]

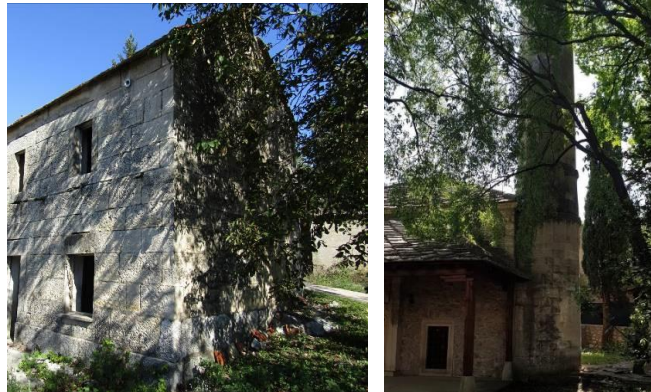
Figures 13-14. Examples of the influence of the surrounding vegetation: a house in Tomića Brig-Vinjani near Posušje, with the influence of the nearby walnut tree on the east side of the building, whose leaves, when washed by rain, acidify the rainwater to some extent (left); The minaret of the mosque near the Bunur pedestrian bridge in Mostar with a more intense patination of the stone due to the proximity of the surrounding vegetation and the Neretva River (right), (photo: K. Šaravanja), [6]

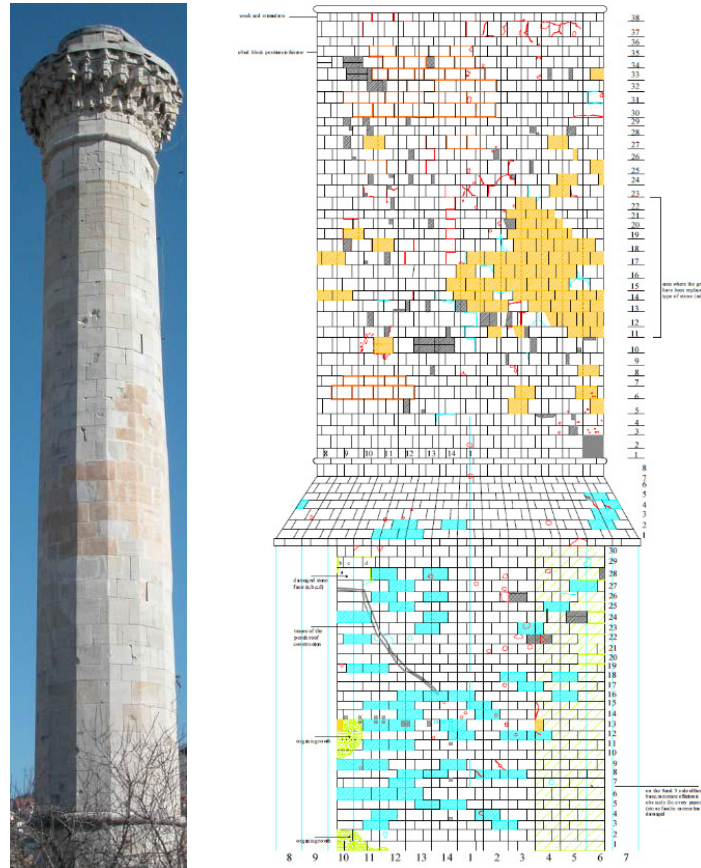
During the renovation of the minaret of the Karadžoz Bey's Mosque (2003-2004), there were stone blocks of lower-quality surface stone (*miljevina*), which were replaced.

Figures 15-16. The minaret of the Karadžoz Bey's Mosque, a national monument of Bosnia and Herzegovina, the oldest building constructed with *tenelija*, before renovation, with visible traces of *miljevina* among the *tenelija* stones (left); detailed drawing showing cracks in red and various repairs in yellow and blue color, and all areas show replaced parts of surface stone (right), [25]

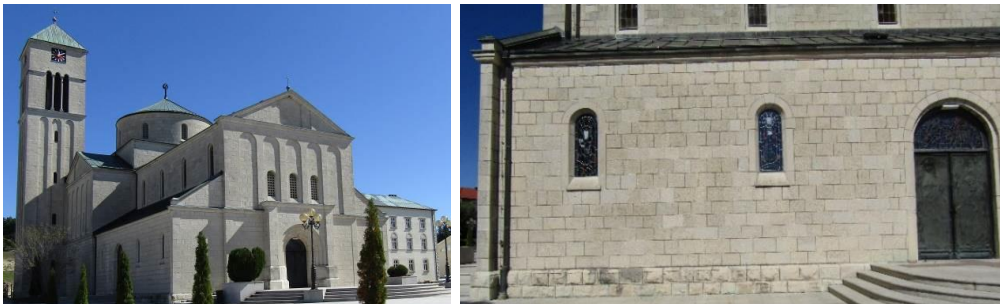
At the church in Tomislavgrad, stone blocks damaged by frost were replaced with newly made dressed stone elements from the same quarry. The damaged blocks had not been installed in the same position as in the bed, thus preventing the layers from coming to a vertical position and moisture from being drawn into them, which led to delamination and disintegration due to the action of ice, [6].

Figures 17-18. Church of St. Michael the Archangel in Tomislavgrad (above); frost-damaged blocks replaced with new cut elements of the same type of stone, (below; photo: K. Šaravanja), [6]

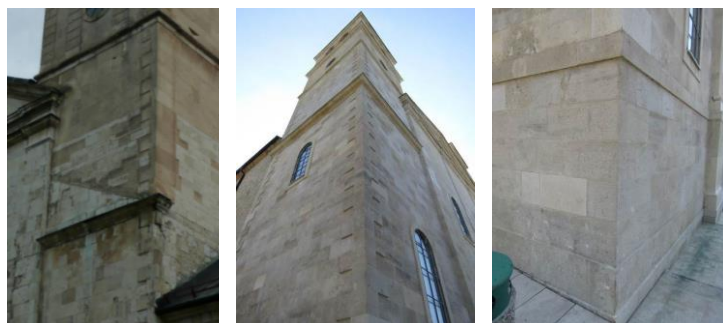
Figures 19.-21. An example of the construction of wall covering of the southern bell tower of the Church of St. Peter and Paul in Gorica in Livno with different types of dressed stone with regard to their color, size and surface processing (left), [29]; The *muljika* stone, which gives a special monumentality to the main facade H, it was restored on the facade and bell towers, (middle and right; photo: K. Šaravanja), [6]

On the church of St. Peter and Paul in Gorica in Livno, the national monument of BiH, the stone was restored on the facade and bell towers during the restoration due to the risk of collapse of the damaged stone. The proposers were the Croatian Restoration Institute from Zagreb and the Institute for Protection of Monuments of the Federal Ministry of Culture and Sports. Before choosing a replacement stone, it was recommended to leave a smaller block to overwinter unprotected in Livno, to make sure that the selected stone would be good for such conditions, [6], [29].

On the church of St. Peter and Paul in Gorica in Livno, it was observed that, due to swelling, the corroded iron connections inside the dressed blocks press the stone and cause its destruction, which leads to its breaking off and formation of large holes in the wall coverings.

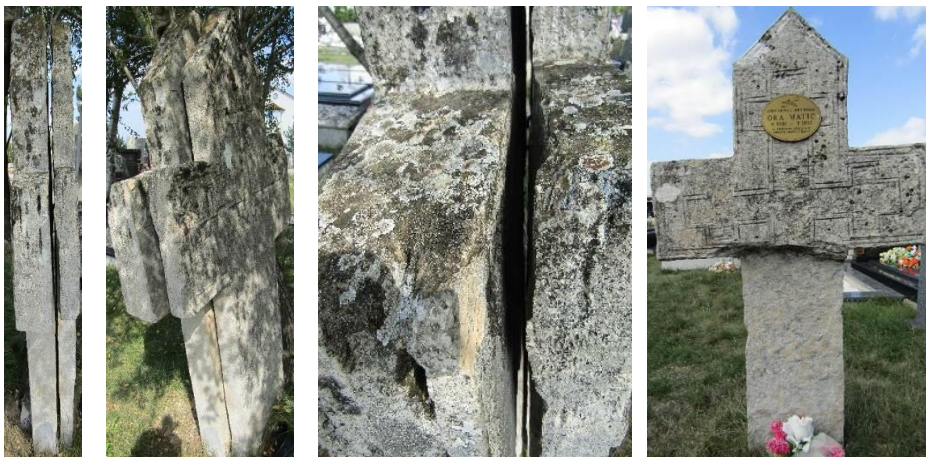
Some tombstones made of freshwater limestone were damaged due to mistakes in the choice of stone and failure to take into account its stratification, so moisture penetrated the stone layers, which led to partial or complete delamination of the tombstone due to frost.

Figures 22-25. Damaged tombstones in the Radoševina cemetery near Tomislavgrad, made of stone muljika, with visible delamination along the height (figures on the left) or on part of the height of the tombstone (figure on the right) due to failure to take into account the stratification of the stone, and long-term exposure to frost, (photo: K. Šaravanja), [6]
