## The Austro-Hungarian hangars in Mostar - Part II

**Gottfried Holzschuh**

**Abstract:** The first part of the survey covers the history of the Austro-Hungarian "Air Base", "Aviation Park no. 4" and "Reserve Squadron 11", which were stationed in Mostar between 1913 and 1918. The airfield of Mostar-Rodoč, evaluated as early as in 1912, was one of the oldest in the Austro-Hungarian Monarchy. The Imperial and Royal Army Air Service used it for basic pilot training in World War I. The second part is an expertise for the salvage, conservation and restoration of the four still existing Austro-Hungarian hangars at the former Mostar-Rodoč airfield in view of protection of historical monuments. Erected in 1917/18, these hangars are the oldest witnesses of aviation in Bosnia and Hercegovina. Because of their genuine and very efficient construction, they should be preserved as unique examples of technical and engineering architecture. One hangar of exactly the same type, restored in 2013 in Krakow, is now part of Poland's cultural heritage. Structural calculations have shown that these Austro-Hungarian hangars comply with modern EU building regulations. All used documents and plans from th

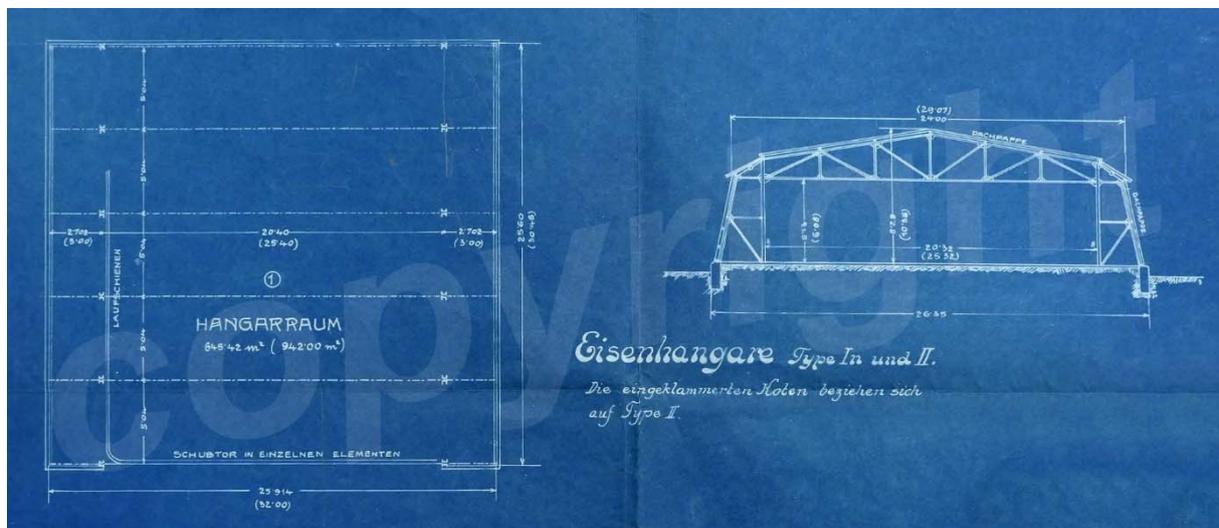
Figure 12. Waagner hangar, plan view and section with measurement data of types *In* and *II* (ÖStA/KA)

At the beginning of 1916, the army air service ordered 50 pieces of iron hangars *in sizes I* (no. 3223 - 3242), *II* (no. 3311 - 3330) and *III* (no. 3411 - 3420) from the Vienna bridge construction company Waagner, Biró & Kurz AG to equip their airfields (Figure 11). This type of hangar was already proven; the same number were even erected at the Aspern Aviation Authority, at the aviation depots in Aspern and Fischamend, the equipment supplier Strasshof as well as some reserve squadrons. It was a riveted truss frame structure made of iron, the individual elements connected by screws to make the parts transportable. The flat mansard roof with truss beams was equipped on both sides with skylights at full length. Admittedly, the internal supporting structure reduced the usable area for aircraft, but the space between the girders could be used for workshops and depots. The front of the hangar could be opened almost completely by means of sliding door panels that moved inwards on rails (Figure 12).

For its hangars, Waagner delivered only the iron framework to the Army Air Service. The necessary foundation works, carpentry and roofing works had to be advertised and assigned to local construction companies at each building site. The roof and walls were given wood panelling that was sealed with bituminous roofing felt on its outside. The wooden doors on lattice iron frames were impregnated instead. Additional windows, ventilation accessories, built-in storage spaces, heating, eaves or lightning rods were not part of the original catalogue of demands of the Austro-Hungarian Technical Committee but were a possible option. The complexity of construction and overall costs were considerably higher than for Lord wooden hangars of the same size, but resistance to wind pressure and snow load was greater.

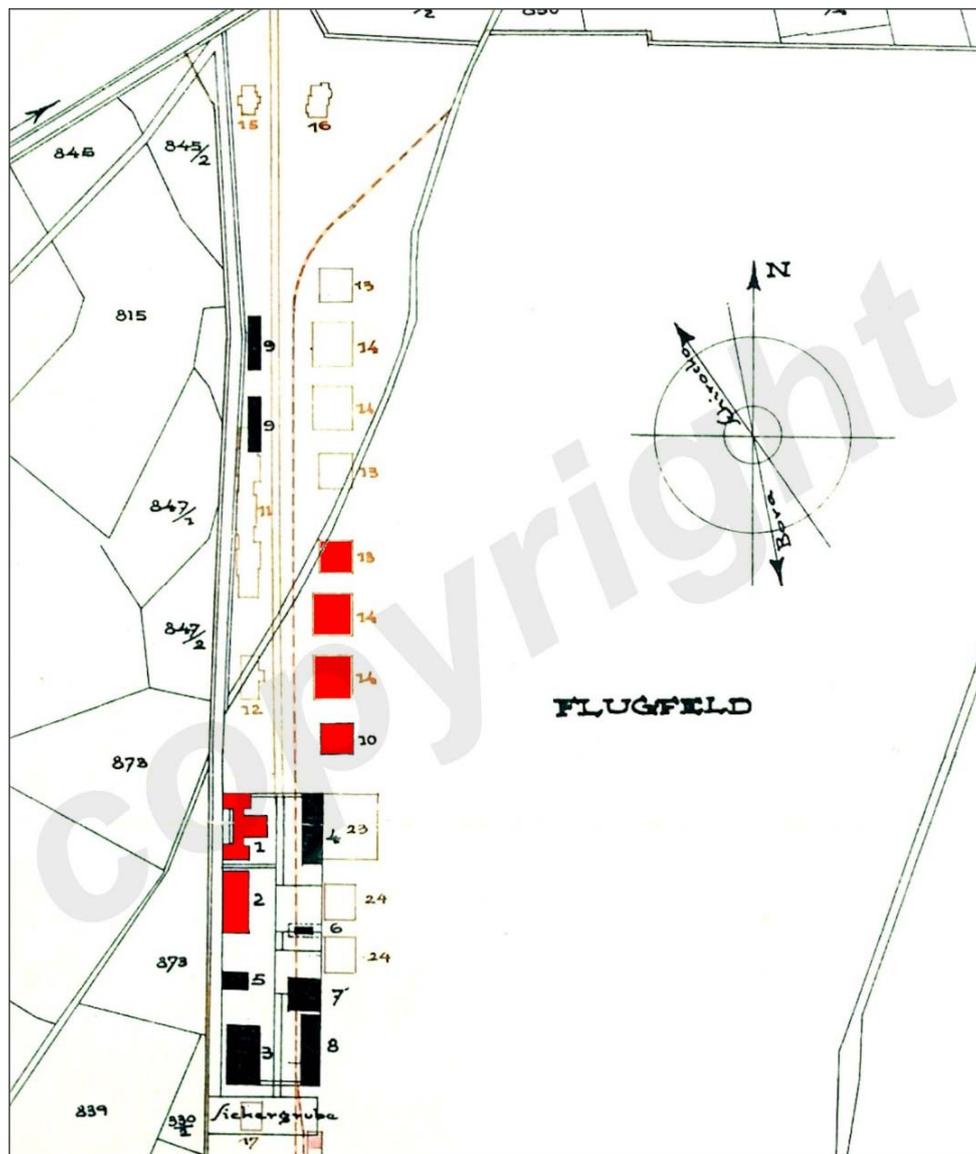
Figure 13. The Rodoč airfield with projected expansion in 1917 (section). Preserved Austro-Hungarian buildings are marked in red. In the wind rose, the predominant wind directions of "Bora" and "Sirocco" (ÖStA/KA).

In September, the Mostar Construction Administration asked how the second *In type* hangar should be placed. Like at most other sites with iron hangars from Waagner, they should be placed in Rodoč in groups of four, with two large *type II* hangars in the middle, and

a small *type In* on each side (see Figure 13). When the iron material, sent off on 24 September, arrived at Mostar railway station in the beginning of October, the local Construction Administration called by telegraph for its own truck to be sent, because the existing *Flek's* truck was not strong enough. In early November, the Franz Scheidig company from Sarajevo, which was entrusted with the construction, had not yet completed the foundations for the second hangar 3239. The delivery of two larger *type II* hangars was also announced for October by the Army Air Service Construction Department in Vienna, and the Scheidig company was again designated to execute the work.

The further expansion plan anticipated two reserve squadrons with eight iron hangars to be set up at larger airfields due to the acute need for pilots. That is why in March 1918 the basic training in Mostar was extended to training of the advanced category II, and old training aircraft *Oeffag C.I series 51* with 160 HP Daimler engine were delivered for this purpose. On 20 January the Construction Department urged the Command of the Army Air Service to speed up construction of hangars designated for Mostar, since "this airfield, although it is one of the oldest ones, is the most underdeveloped in terms of hangar space." Out of a total of eight planned iron hangars, only one was set up, and three others were under construction (Figure 13).

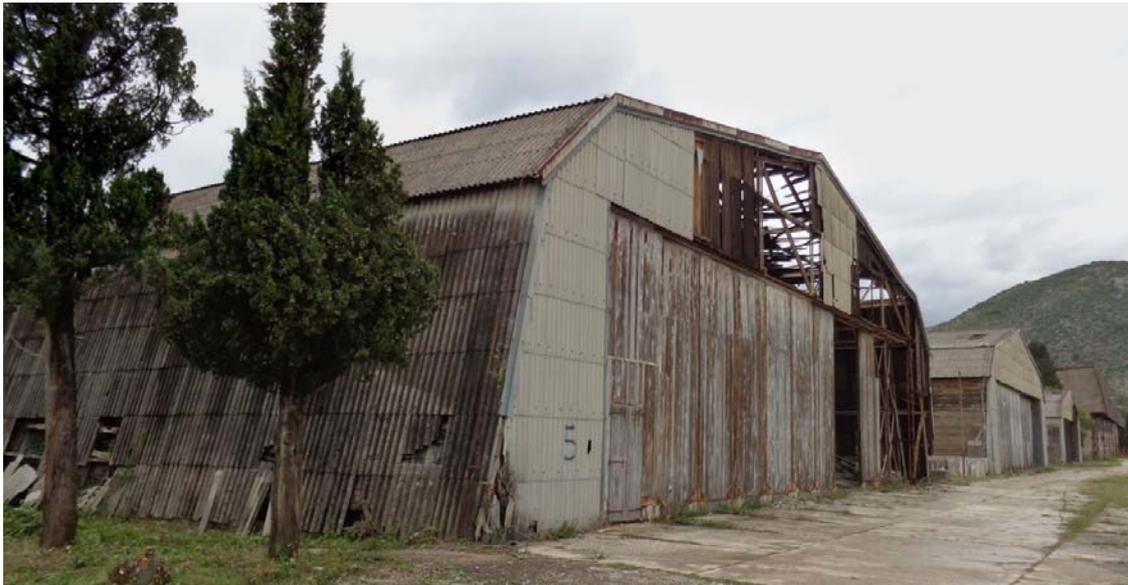
Figure 14. *Type II* Waagner hangar (no. 5) in Mostar (M. Martinović)

At first impression, the present condition of the four hangars is poor. There is damage from the Bosnian and Herzegovinian war primarily to the wooden panelling of roofs, walls and doors. But the iron truss structure appears to be still intact to a large extent (Figures 1, 14, 16). It was only supplemented by masonry walls on their backside (Figure 18). The typical skylights were covered at some point with wooden panels, and the whole buildings with corrugated sheets of cement fiber. Reconstruction of the wooden parts is easily possible, as from the identical Waagner hangars presently standing at the old airport in Innsbruck, Austria, detailed estimates with data on the dimensions of roof purlins and rafters, squared timber and panelling have been preserved.

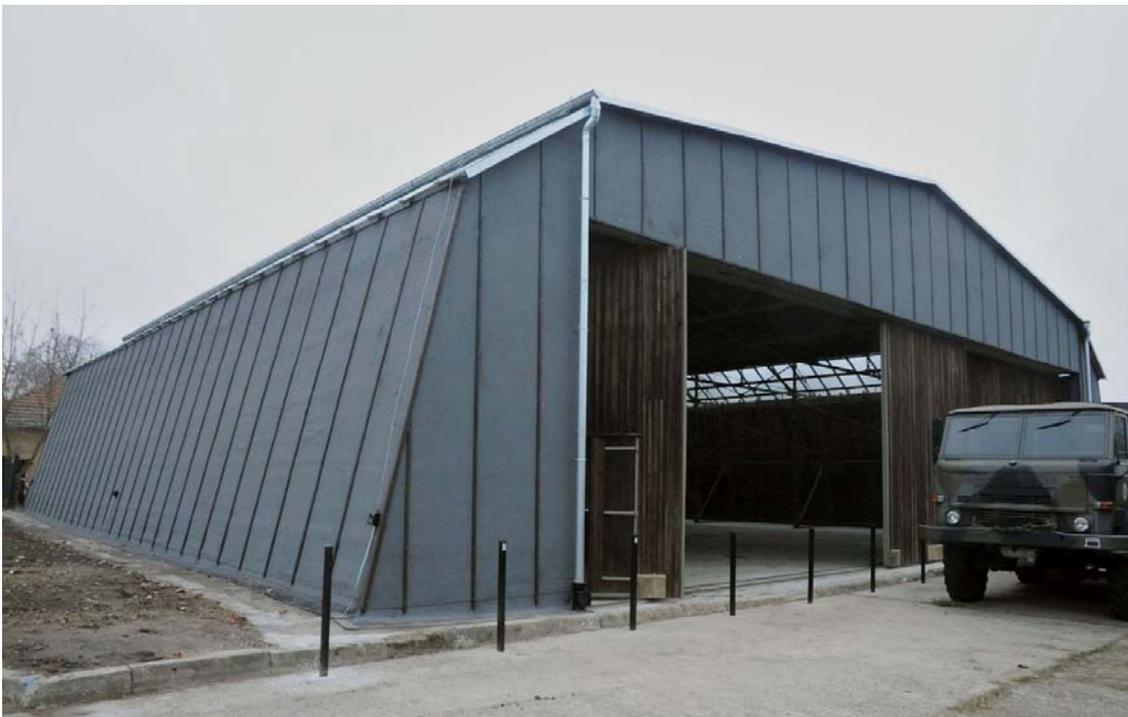
Figure 15. Immaculate restored *type In* specimen in Krakow. The eaves gutter with drainpipe and lightning rod are modern, but "accessories" that make sense

The model for proper restoration is beyond doubt the *type In* Waagner hangar in Krakow. It is located on a site of barracks of the former Krakow-Rakowice airfield, the original base of *Flek 10* in the northeast of the city. Its exceptional value as the last preserved on-site Austro-Hungarian hangar (Figures 15, 17) was recognized as part of a large survey of historic buildings (Figure 19) located there. According to the stamps on the iron support columns, the load-bearing structure was produced in 1916 in the Bohemian (Czech) steel plant Kladno (Kladno).

The restoration was financed from the resources of the Polish Ministry of Defense and the National Fund for Historical Monuments of the City of Krakow. The main works that were performed from July to November 2013 consisted in restoring the structure to its original technical condition and protecting it from microbiological risks and harmful environmental impacts. The iron parts were cleaned of corrosion and protected with anti-rust agent.

The structural calculation of truss girders proved to be completely sufficient according to present-day construction standards in terms of wind pressure and possible snow load, taking into account the prestressed structure. The restoration of the rope tensioning system could not only re-establish prestressing, but also the overall structure. This had completely lost shape when hit by a German air force bomb on 1 September 1939. The readjustment enabled the new setting of the valuable sliding door mechanism that allows efficient opening of the hangar doors, almost without effort.

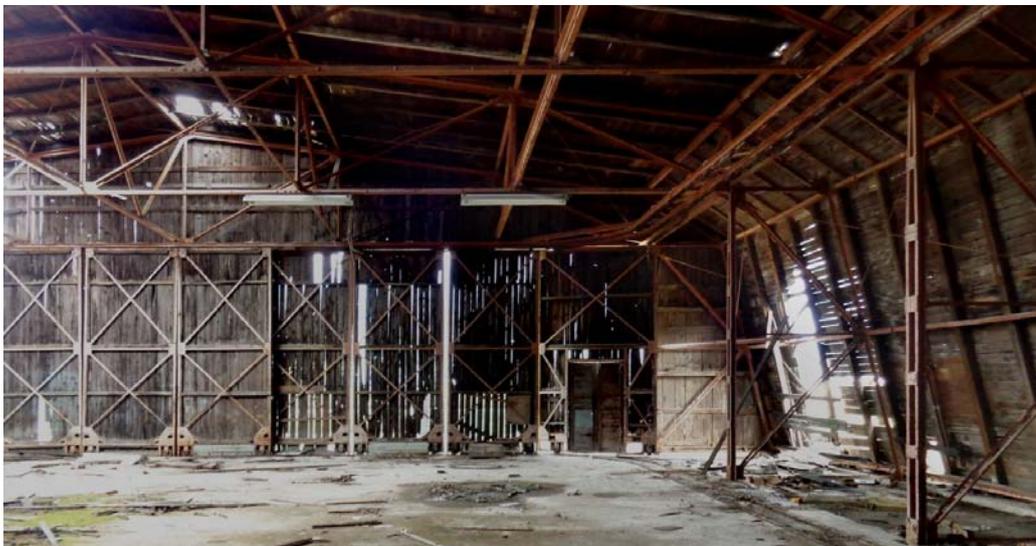
Figure 16. *Type In* hangar (no. 3) in Mostar: the iron frames and rails for the sliding door elements are intact (M. Martinović)

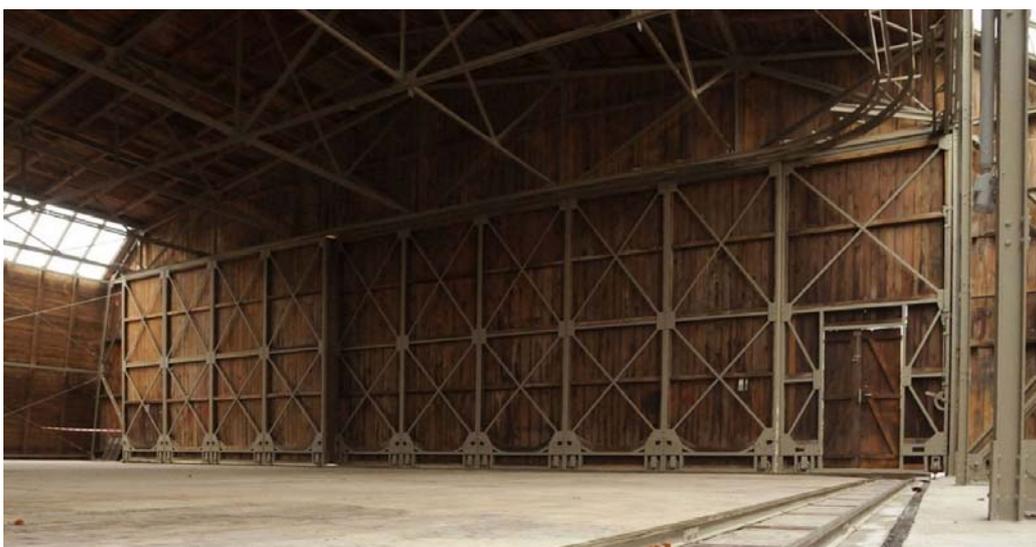
Figure 17. Vision for the re-establishment of the Mostar hangars. The Krakow hangar still lacks a wooden floor, so the door rails raise over the floor horizon

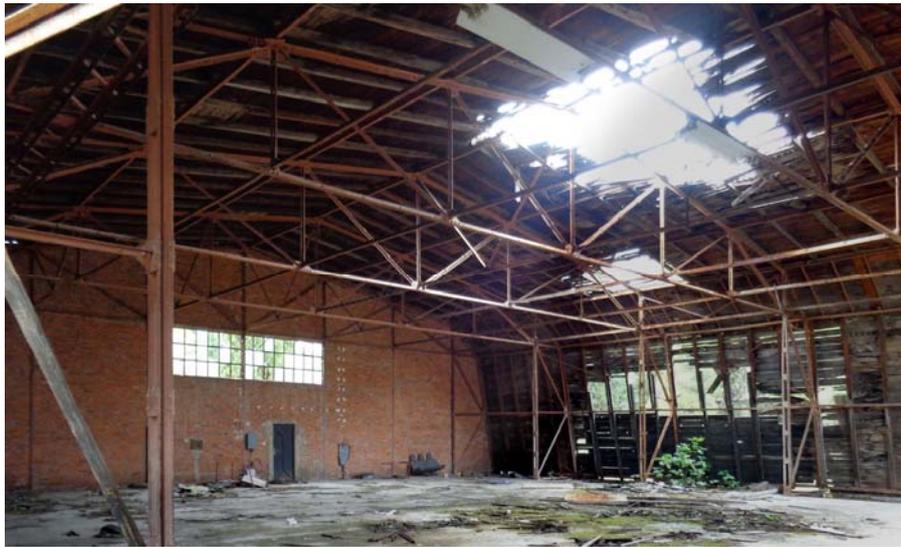
Figure 18. Hangar no. 3 with shell hit. The brick-built back wall does not belong to the original hangar construction (M. Martinović)

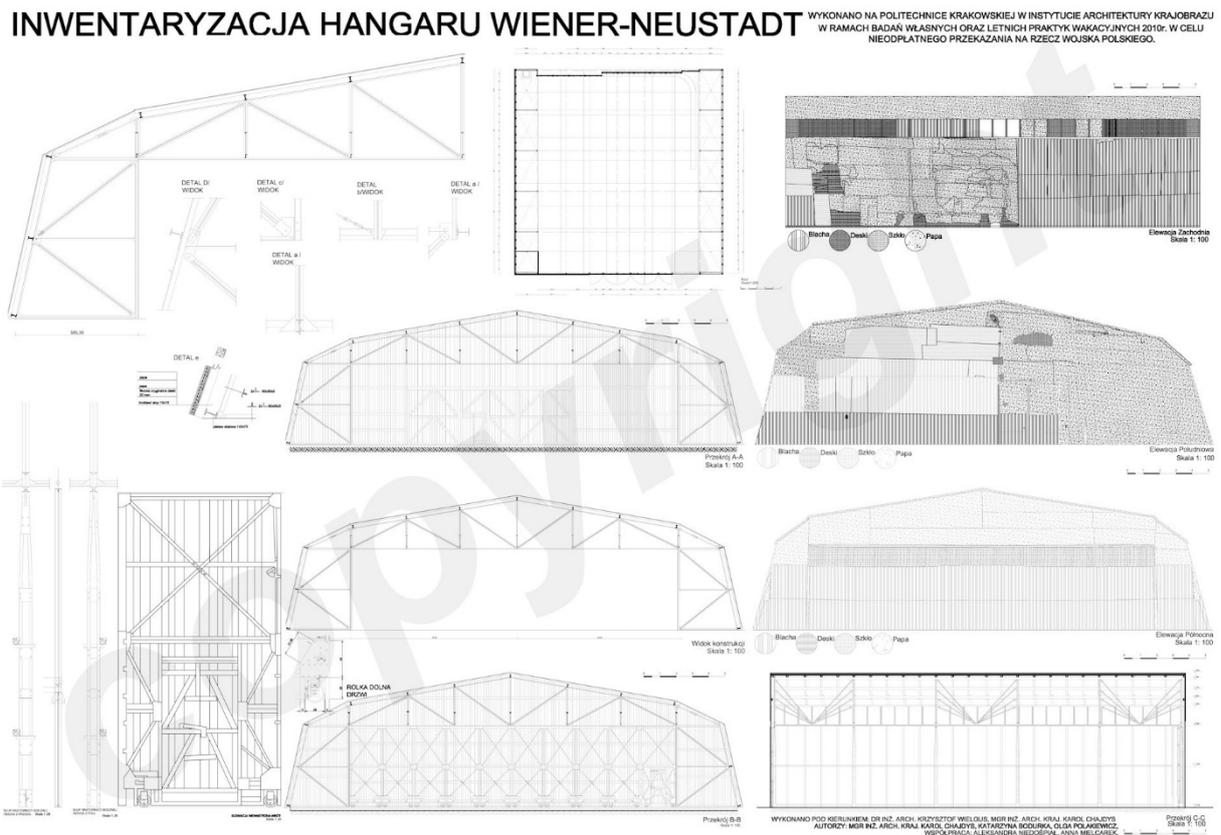
Figure 19. Construction drawing with details of the Waagner hangar structure in Krakow, the type designation "Wiener Neustadt" is misleading (K. Wielgus)
