Geotechnical characteristics of the banks in the middle course of the Neretva River through the City of the Mostar

Abstract: Regulation Plan for the historic town area of Mostar includes major aspects of preservation and development of historic town zones. Provisions of the Regulation Plan pertain to use of land and buildings, aiming to preserve and revive the traditional uses and protect the natural characteristics of the area [8]. In this respect, the historic area of the town of Mostar has been divided into ten zones according to the use of land and structures, and Zone 8 covers Neretva as a protected riverside zone. The study aimed to define causes and state of weathering, damage and stability of rocks, then to define the existing state in terms of geological structure, and visit the most critical sections that require improvement.

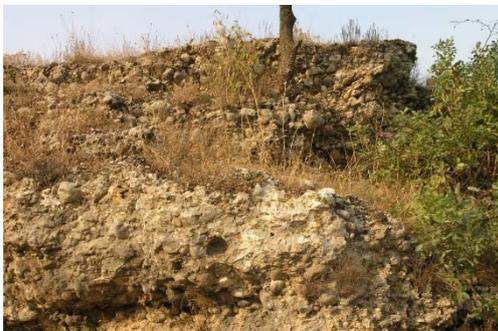
Figure 1. A view of the upper roof cover part of a river block

The river terraces are developed as blocks separated from each other. Each river terrace block has the lower, underlying and upper, roof cover part. The shortest distance between the underlying and overlying part of a block is its thickness (Figures 1 and 2), [6].

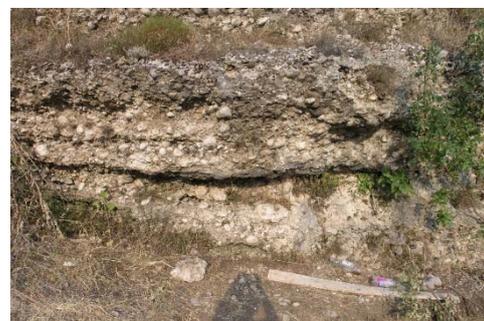
Figure 2. A view of the lower underlying part of a river block

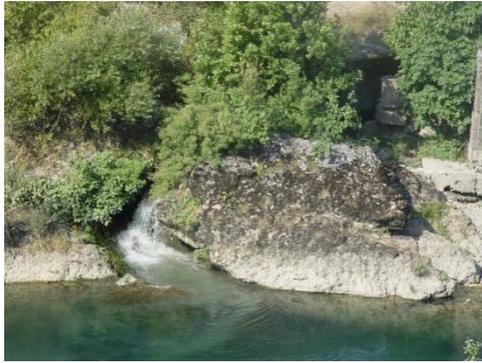
Figure 3. Detached blocks in the riverbed

As voids between blocks of river terraces develop, these blocks become stressed in terms of support, and because of the development of tensile zones in the overlying part, they fail and break off toward the river bed. Such blocks can be seen in the riverbed and on the banks (Figures 3 and 4).

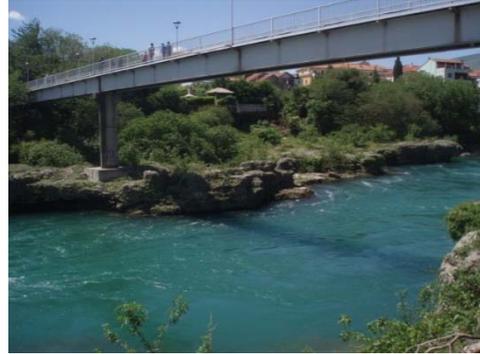
Figure 4. Fragmented rocks on the right bank

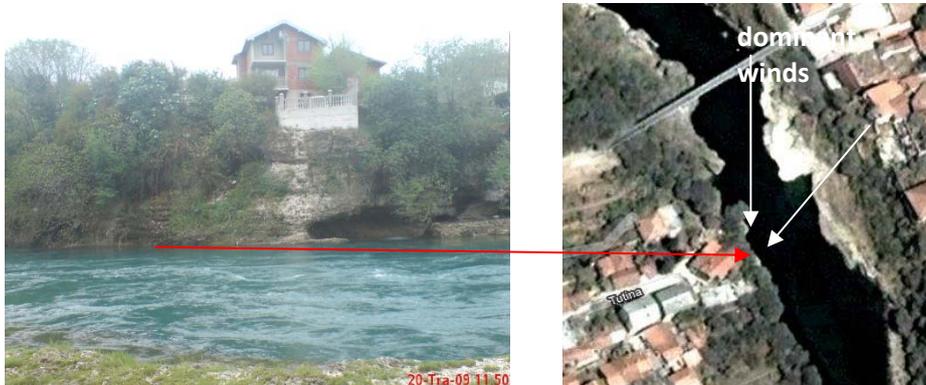
Figures 5. and 6. Influence of waves on banks at the Bunur site

Taking into account that the study area around Bunur, Figure 5, is exposed to gusts of bora, the dominant direction of waves is N and NE. Relevant winds can be obtained from

At the Bunur site (Figures 5 and 6), the river makes a left turn, which points to the fact that the left bank is more compact in geomechanical terms, and the river flow "reflects" toward the right side with weaker mechanical characteristics. Here, it is certainly necessary to emphasize the impact of increased flow through HPPs on Neretva during flood flows, in particular HPP Mostar, when waves can reach even several meters in size. Their impact on breakage of banks is certainly significant but also insufficiently investigated in the last 30 years or so.

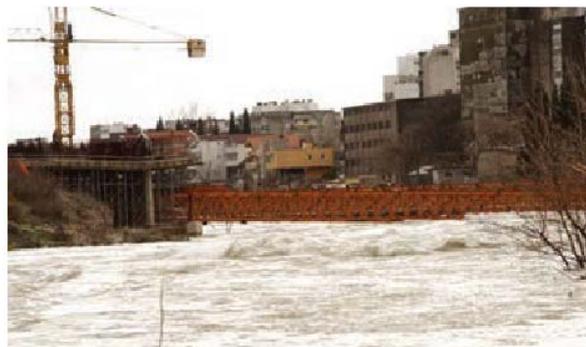
Figure 7. Construction site of the New Bridge in 2010 [11]

Observing the wider area, we select a picture taken during construction of the New Bridge on the Neretva River. At the end of 2010, the bridge construction site was flooded with water of a recurrence rate greater than a 100-year high water [11].

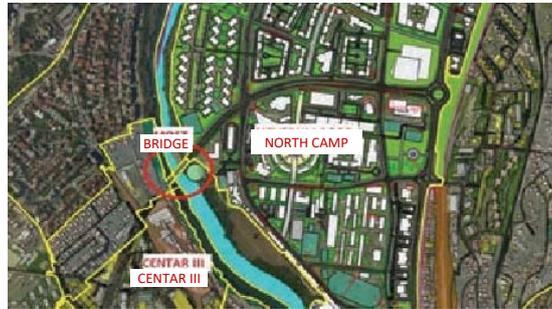
Figure 8. Location of the New Bridge on Neretva [11]

Observing the location of the New Bridge in Figure 8, it is evident that on the concave (right) bank there is a greater risk of bank erosion [13], and thereby a negative impact on the bridge pier foundation. Consequently, protection of the right bank was carried out near the river pier of the bridge by constructing rip rap of large stone blocks - Figure 9.

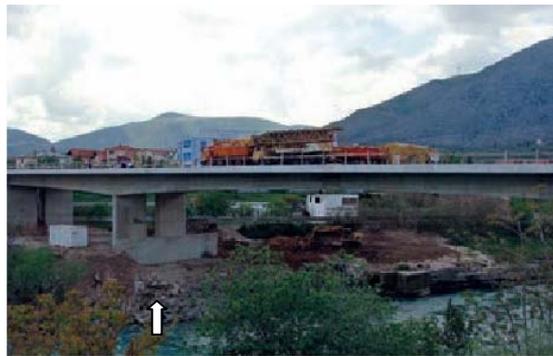
Figure 9. Protection of the right bank near the river pier of the New Bridge on Neretva [11]

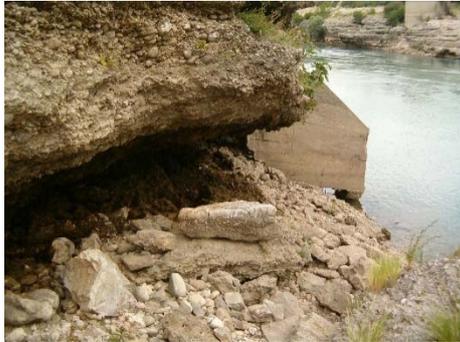
Figure 14. A scoured layer of conglomerate susceptible to collapsing

The formed underground voids cause the effect of cantilevers in river terraces, and they break off in the form of large blocks and fall into the riverbed (Figures 14 and 15), [7].

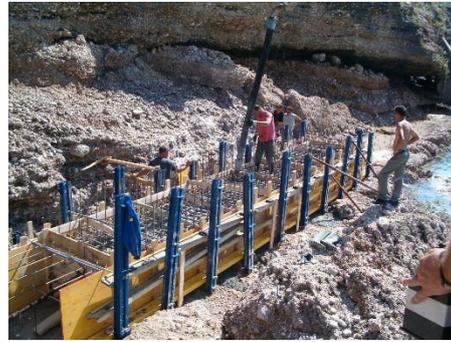
Figure 15. An example of intervention
