A contribution to the research of Mostar miljevina with special reference to frost resistance

Abstract: The paper presents the freshwater limestone Mostar miljevina (miljevina). In the diagenesis process, it acquired a specific orientation and structure, which gave it specific physical properties that geologically older, compact (dense) limestones do not have. The results of the previous tests of miljevina from the Mukoša deposit near Mostar and from several buildings in Mostar are presented. Miljevina is less crystalline, less dense, and thereby less resistant to the processes of chemical deterioration and deterioration caused by crystallization. Due to the high absolute porosity of the open pores, miljevina has high moisture absorption and pronounced capillary water absorption, so it was not desirable to install it on surfaces directly exposed to wetting by rain and gusts of wind, but it was protected by facades, with the use of another type of stone in the part of the building in contact with the ground. The second part of the paper presents the results of testing miljevina as part of the graduation thesis, especially frost resistance, with appropriate conclusions and compariso

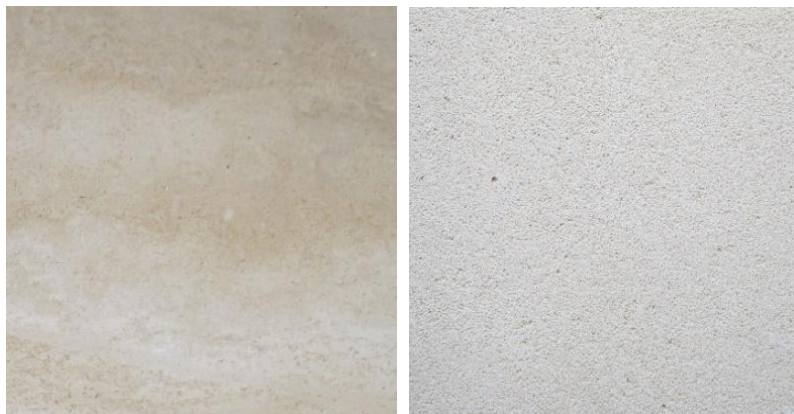
Figures 4-5. Photographs of cut samples of miljevina (left) and tenelija (right) (photo: I. Hajdarević) [13]

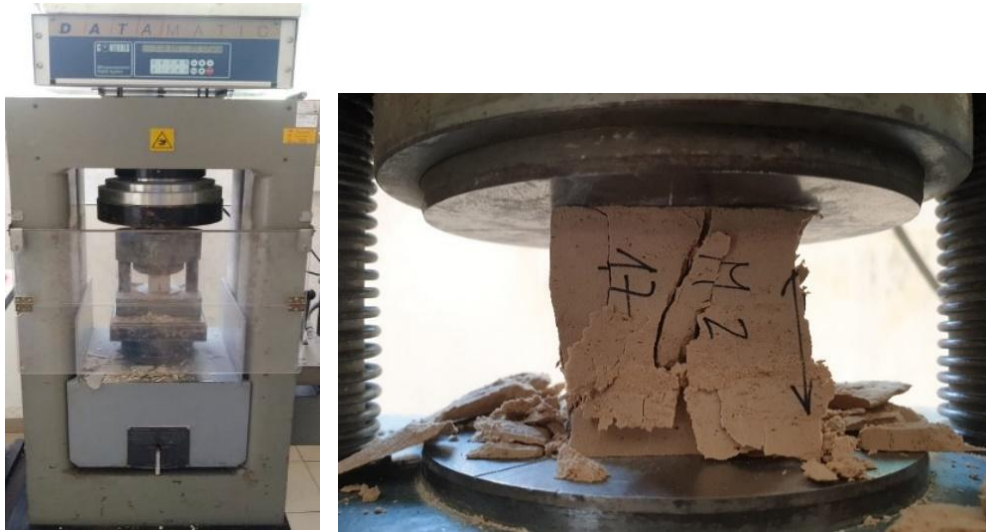
Figures 11-12. Compressive strength testing press with an adapter

Figures 11 and 12 show a compressive strength testing press with an adapter for centering smaller samples (left), with a detail of broken miljevina sample after testing.

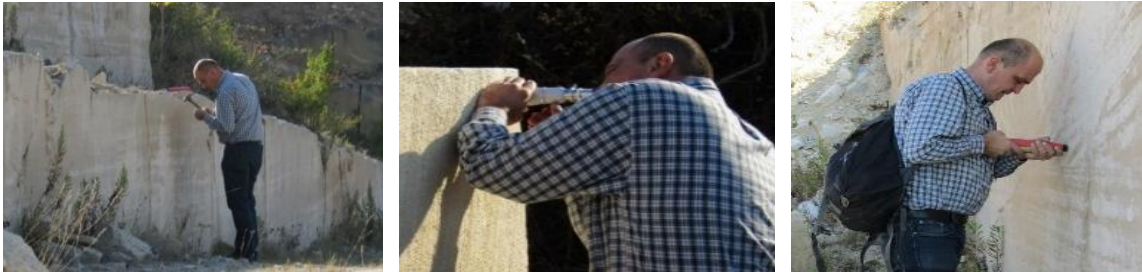
Figures 13-15. Testing of (Mostar) miljevina (new one) from the Mukoša deposit near Mostar with a manual microscope and Schmidt hammer, along with visual inspection (photo: K. Šaravanja) [4,5]

Visual inspection using a manual microscope, as well as "in situ" non-destructive testing (NDT) of the stone using the Schmidt hammer (sclerometer) were carried out at the quarry site.

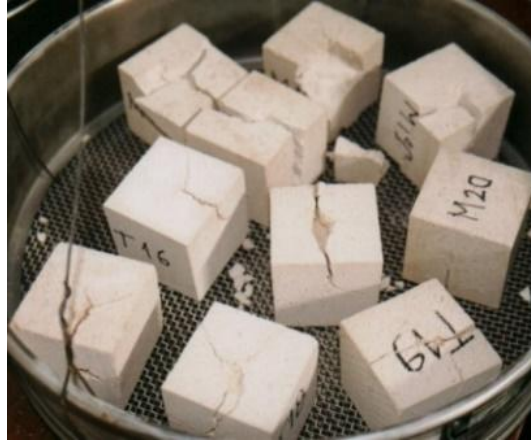
Figure 17. Fracture of (new) tenelija and (new) miljevina samples and test termination after only 3 of the planned 25 cycles of freezing and thawing in IGH-MOSTAR in 2002 [26]

- after 25 cycles of freezing and thawing according to the JUS B.B8.001 standard:
- in IGH-MOSTAR (2002) after only 3 of the planned 25 cycles carried out on 5 samples of miljevina, the test was stopped due to the occurrence of cracks and breakage of samples, with the conclusion that miljevina is unresistant to frost action);

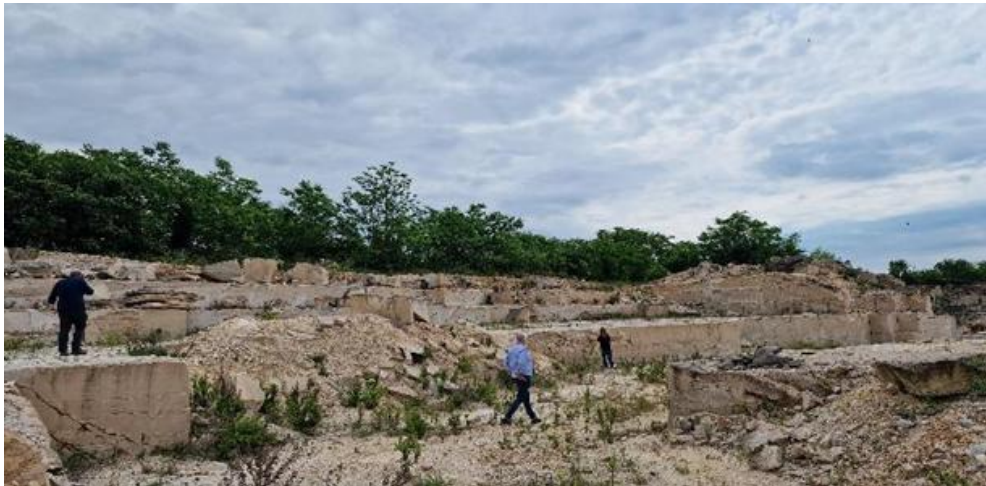
As part of preparation of Milica Rončević's graduation thesis, the first step was a visit to the Revigrad company and the Mukoša deposit, during which various layers were examined, especially the tenelija intercalations within the miljevina beds. In addition to the analysis of available literature and test reports, the visit to the quarry was important for planning the research within this graduation thesis (Figure 20).

Figure 20. Visit to the Mukoša deposit near Mostar at the beginning of development of the graduation thesis [27]

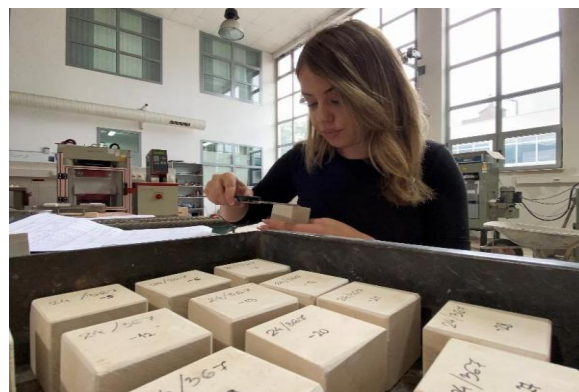
Figure 23. Measuring the dimensions of test samples in the Central Laboratory of IGH d.o.o. Mostar [27]

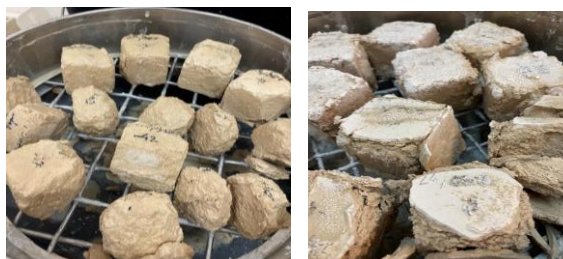
Figures 31-32. View of tested samples of colorful miljevina, mark 24/368, destroyed by magnesium sulfate (left) and sodium sulfate (right) [27]

For both varieties of miljevina, frost resistance testing was conducted using three methods, two of which were crystallization, with magnesium sulfate (BAS EN 1367-2) and sodium sulfate (JUS B.B8.002 standard), and after 25 freezing and thawing cycles (JUS B.B8.001 standard) (Figures 31-32.).

- Loss of shape: Most of the stone samples have lost their original cube shape. The edges are visibly rounded, and many samples no longer look like regular cubes. This indicates significant material wear and erosion of the edges and surfaces due to the wetting and drying cycles in the MgSO_4 solution.

- Reduction in dimensions: The dimensions of the samples are visibly reduced, which means that a significant part of the material has eroded or fallen off during the test. The pieces are smaller than would be expected for cubes with edge of 5 cm, which confirms degradation.

- Cracks and breaks: The surface of some samples shows cracks and breaks, which is a sign of physical damage. Small pieces of stone that have separated from the main samples can be observed, further indicating their brittleness after exposure to the MgSO_4 solution.

- Change in texture and color: The texture of the stone appears rougher and less compact than before testing, which may be the result of salt crystallization within the pores of the stone and their expansion during the cycle. A change in the color of the stone can be observed due to the chemical reaction between the sulfate and the mineral composition of the stone.

- Surface degradation: White deposits of salt are visible on the surface of the samples, which indicates the crystallization of sodium sulfate within the pores of the stone. The surface of the samples is coarse and rough, which suggests significant damage and erosion of the material.

- Physical damage: Several samples show severe cracks and breaks. Parts of the samples have separated, which indicates a high degree of degradation. Some samples have broken into smaller pieces, which is a sign that the internal structures of the stone were under great stress due to salt crystallization.

- Reduction in size and shape: Samples no longer have a regular cube shape. The edges are considerably damaged, and the dimensions of the samples are reduced due to erosion. Changes in shape and volume clearly indicate that the material has lost a significant part of its mass.

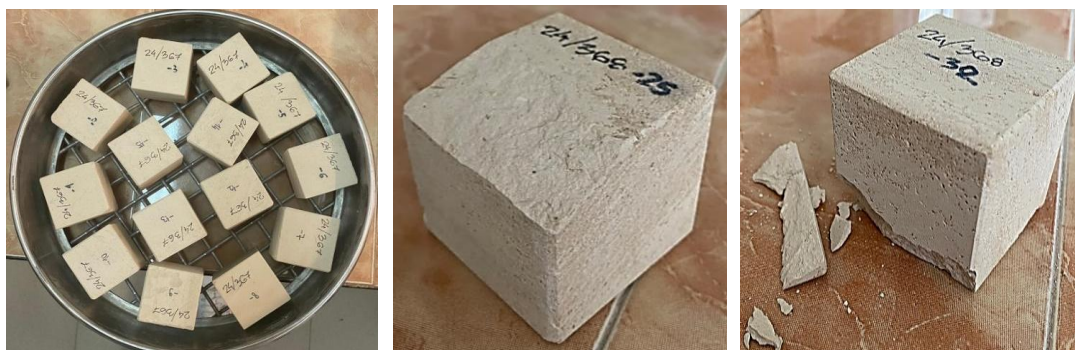
Figures 33-35. View of the colorful miljevina samples, mark 24/368, used during the testing with 25 cycles (left); view of the damaged edges of the samples after testing the samples with mark 24/368-25 (middle) and 24/368-32 (right) [27]

By testing with 25 freeze-thaw cycles according to the JUS B.B8.001 standard, the effect of freezing and thawing on the stone was simulated in order to assess its resistance to cyclical temperature changes that can cause physical damage. The standard is especially useful for assessing materials that will be exposed to extreme weather conditions. Before and after completing all cycles, the samples were weighed to determine the mass loss, which is expressed as a percentage of the initial mass of the sample. The samples were inspected for physical damage such as cracks, breaks or other types of degradation.

All results, including measurements of mass loss, changes in volume, density, and visual observations of the samples of colorful miljevina, mark 24/368, were documented and analyzed. Changes in the mass of the samples before and after the test with 25 cycles of freezing/thawing on 17 undamaged samples out of a total of 21 samples were minimal and were 0.00-0.19%. Peeling, crumbling and cracking were observed on 4 samples, with changes in mass of 0.09%, 0.18%, 1.48% and 4.38%. Based on the test results, a conclusion was made on the resistance of colorful miljevina to cyclic freezing and thawing and its suitability for use in conditions where it will be exposed to frost.

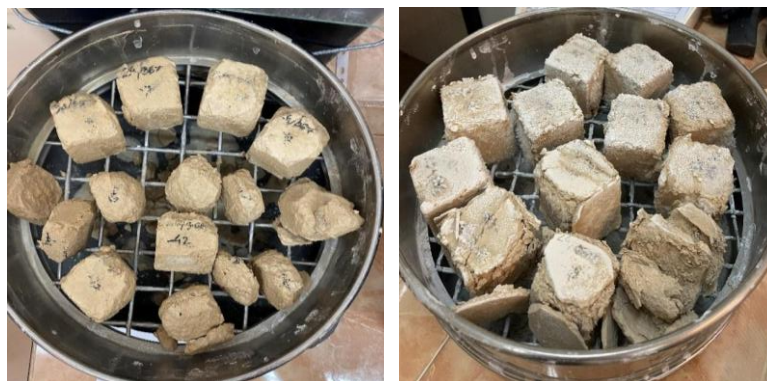
Figures 36-37. View of the tested samples of white miljevina, mark 24/367, destroyed by magnesium sulfate (left) and sodium sulfate (right) [27]

Samples of white miljevina also showed degradation, which is evident from considerably more damaged and deformed pieces, but less compared to colorful miljevina. (Figures 36-37.)
