Influence of environmental (external) factors on durability of freshwater limestones *tenelija*, *miljevina* and *muljika*

Krešimir Šaravanja

HNC Ministry of Construction and Physical Planning and Faculty of Civil Engineering, Architecture and Geodesy, University of Mostar, Ph.D., kresimir.saravanja@fgag.sum.ba

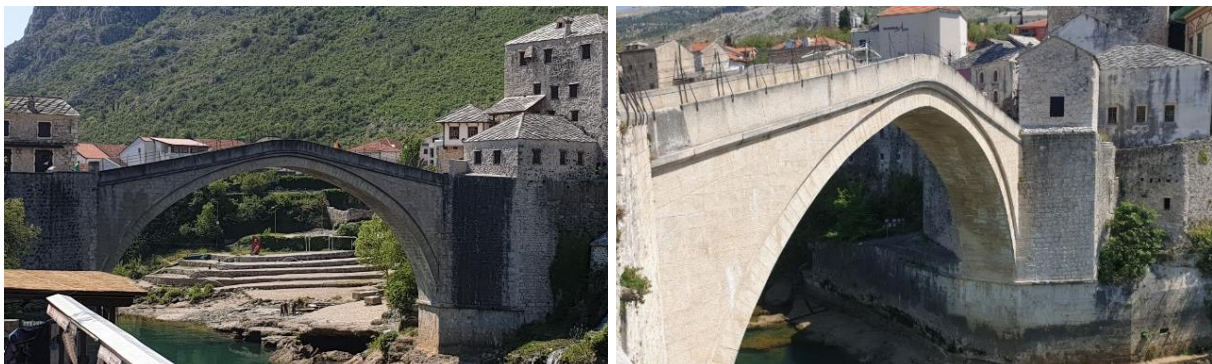
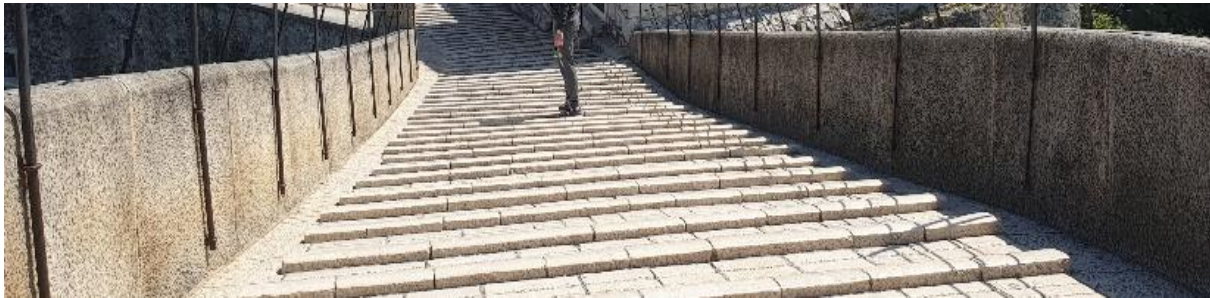
Figures 1-3. The Old Bridge in Mostar, a monument on the UNESCO list of protected world heritage: the upstream, northern side with a more pronounced patina (above, left), compared to the downstream, southern side (above, right); In addition to patina on the arch intrados, patina is visible on the parapets, cornices and vertical walls made of tenelija freshwater limestone; View from the west side of the bridge cobblestone with the inner sides of the parapet showing patina, especially the right, north side of the downstream (southern) parapet (left); damage is also visible on the joints of individual parapet blocks, and on some of them the "lime binder" is washed out, which atmospheric water has partially dissolved over a long period of time so that the joints between the blocks remain empty (below), (photo: K. Šaravanja), [21]

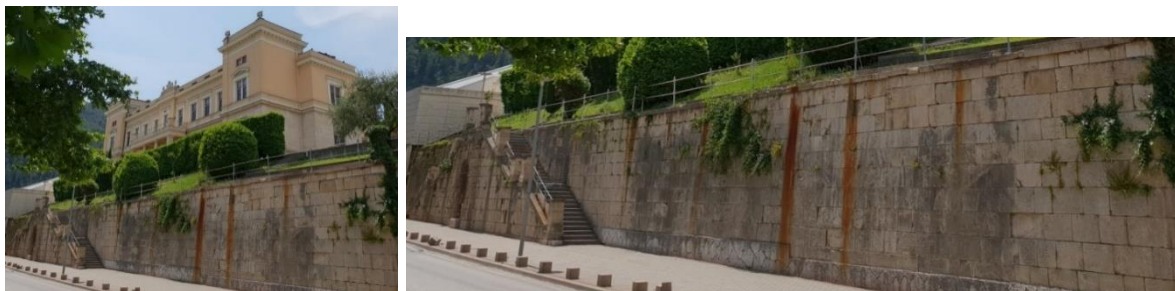
Figures 6-7. Various forms of changes to the stone in the retaining wall of the Bishop's Palace in Mostar (physical impact of atmospheric water, damage from war activities, biocolonization, damage caused by corrosion of the iron fence, anchored in the stone, which corrode in contact with moisture, and the change in volume causes cracking of stone, as well as multi-meter vertical stains on the stone, which are very difficult to remove; The stone in the building of the Bishop's Palace was repaired after the war, (photo: K. Šaravanja), [21]

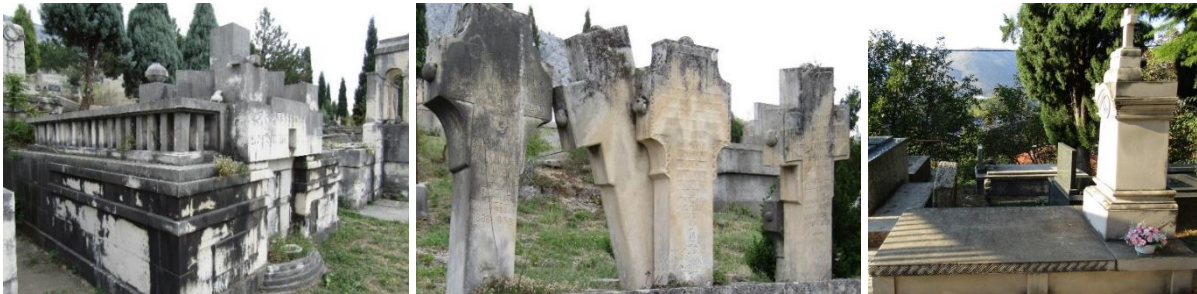
Figure 8-10. Different forms of patination and soiling of surfaces on tombs made of freshwater limestone in Mostar: Bjelušine cemetery (left and center); Although the grave crosses are almost of the same height and shape, they are patinated differently, which indicates not only their different age, but also probably the different quality of the stone, or different layers in the quarry from which they were extracted. The inscriptions on some of them have completely disappeared due to the action of rainwater or are difficult to read (middle); The contrast between the dark (horizontal) and light (vertical) stone surfaces of the tomb in the Šoinovac cemetery in Mostar, along with the patinated inclined and smaller horizontal surfaces of the tombstone, create the impression that the tomb made of (Mostar) miljevina was made of several types of carbonate lithotypes (right), (photo: K. Šaravanja), [21]

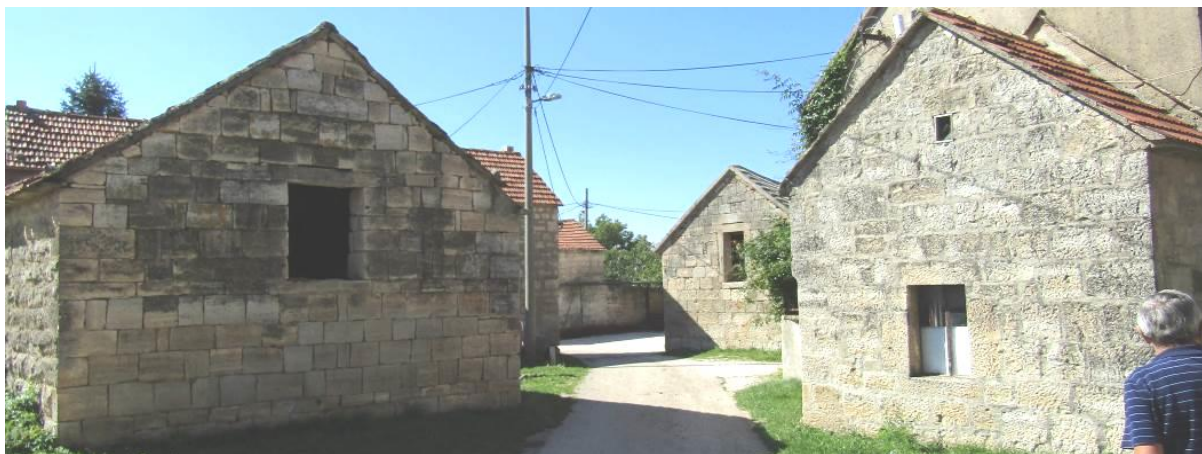
Figure 11. Relatively little patination of facades made of (*Posušje*) miljevina in Ramljaci-Čitluk near Posušje; Orientation of the building and its position in relation to the adjacent buildings are important, so there are certain differences when it comes to a standalone building, or a building that is the first/last in a row, (photo: K. Šaravanja), [21]

In the area of the municipality of Posušje, to reduce construction costs, walls of houses together with facade were built with (*Posušje*) miljevina, which was quarried in several locations 80-160 years ago.

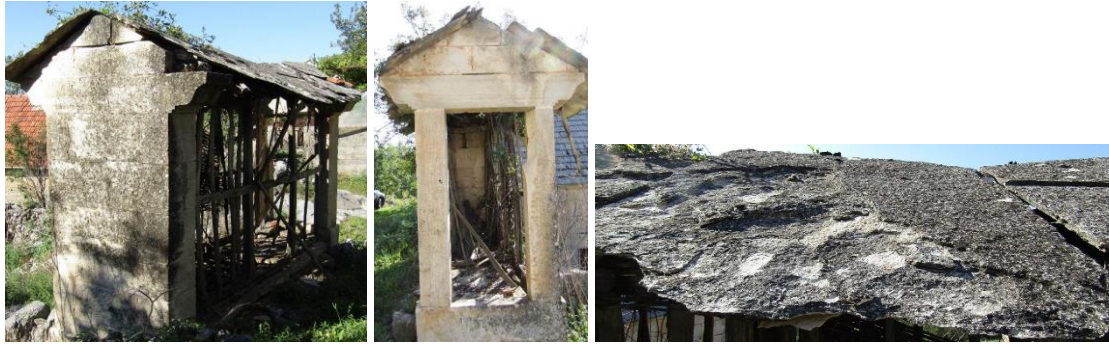
Figures 12-14. Corn storage (corn crib) in Tomić Brig near Posušje, about 120 years old, with dimensions 3x1.5 m; one can see the excellent preservation of the (Posušje) miljevina stone, especially the entrance part, which has less patina (middle); A cover made of stone slabs 0.2-0.3 m² in area, about 3 cm thick, covered with patina, with some lichen (right) deserves special attention, (photo: K. Šaravanja), [21]

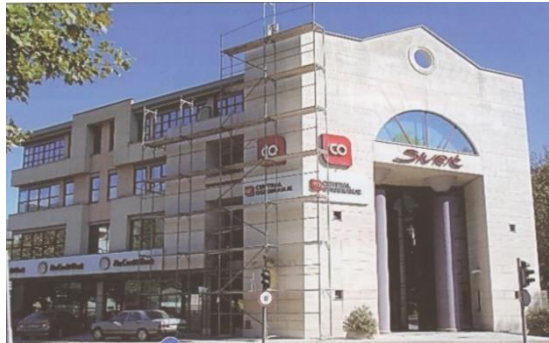
Figure 15. Removal of patina from the facade of the "Sivrića" building in Mostar made of tenelija (end of 2016), [22]

Buildings made of *miljevina* (and *tenelija*) have an advantage over buildings built with hard limestone due to the easy refreshing of the facade by removing patina from the stone by hand or by machine.

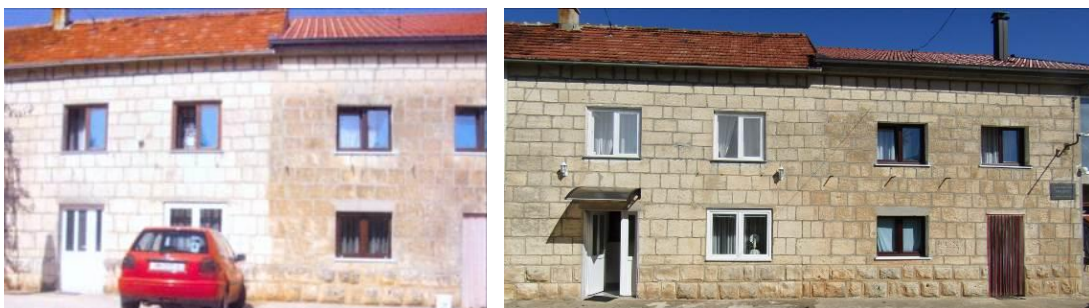
Figures 16-17. An example of removal of a layer of stone with patina from the left part of the facade made of (Posušje) miljevina on the house in Vinjani near Posušje with a special tool (pick with 3 teeth). An 8-10 mm thick layer was removed from an area of about 50 m² in 3 days, (left, photo: F. Oreč, 2011). Eight years later, a certain return of the patina is visible on that part of the house, (right, photo: K. Šaravanja, 2019), [21]

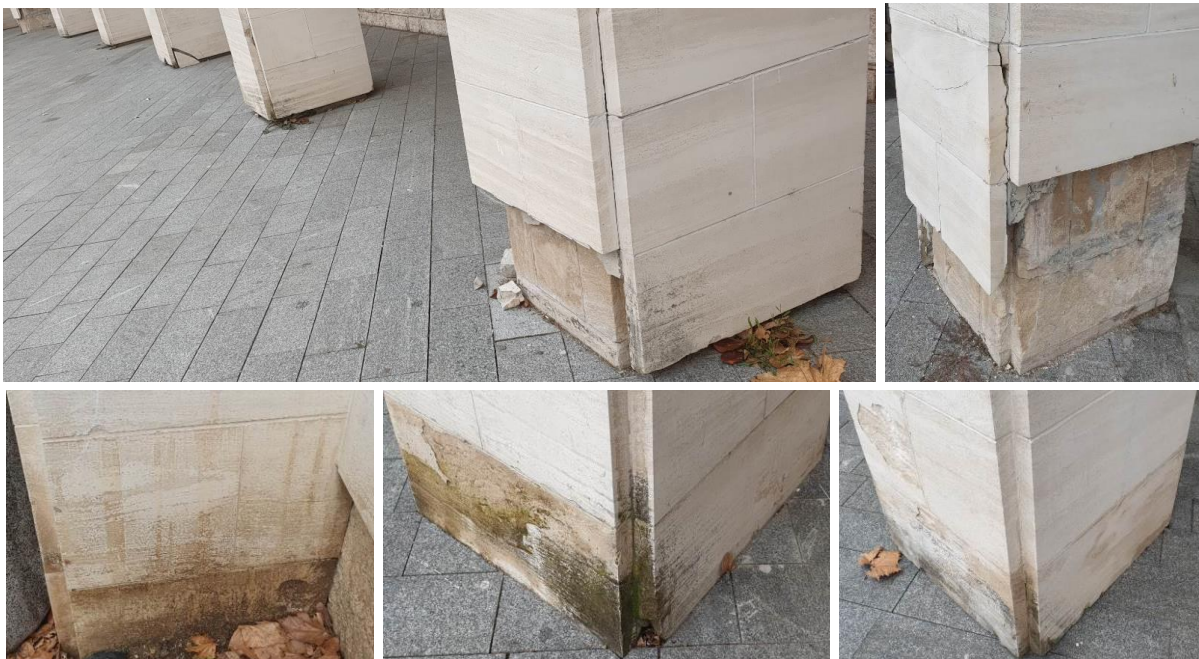
Figure 18-22. Deterioration of the lower part of the facade made of (Mostar) *miljevina*, which is used for decorative and protective covering in the form of a thin stone base of the Croatian Center Herceg Stjepan Kosača in Mostar due to the physical impact of atmospheric water and moisture, (photo: K. Šaravanja), [21]

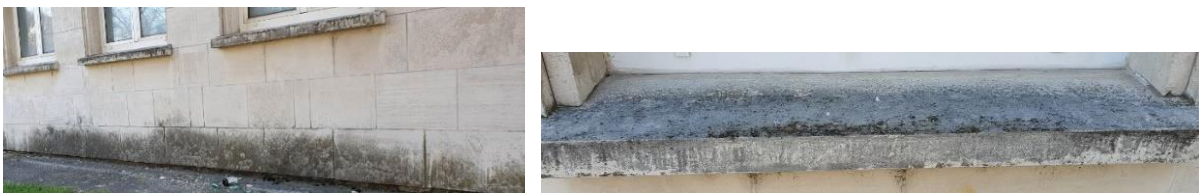
Figures 23-24. Deterioration of the lower part of the facade made of (Mostar) *miljevina*, which is used for decorative and protective cladding in the form of a thin stone base and stone sills under the windows of the Croatian Center Herceg Stjepan Kosača in Mostar due to the physical impact of atmospheric water and moisture, with a detail of the sill under the window, (photo: K. Šaravanja), [21]

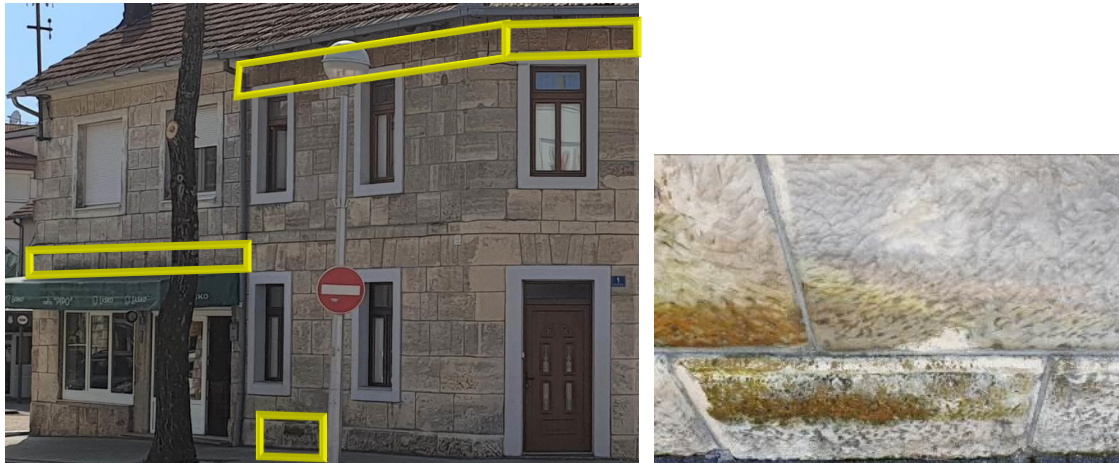
Figures 25-26. The effect of atmospheric water under the roof gutters and above the awning on a house in Posušje made of (*Posušje*) *miljevina*, more pronounced in the lower part of the building due to the capillary rise of rainwater (and snow), with detail (fungi and lichens), (photo: K. Šaravanja), [21]

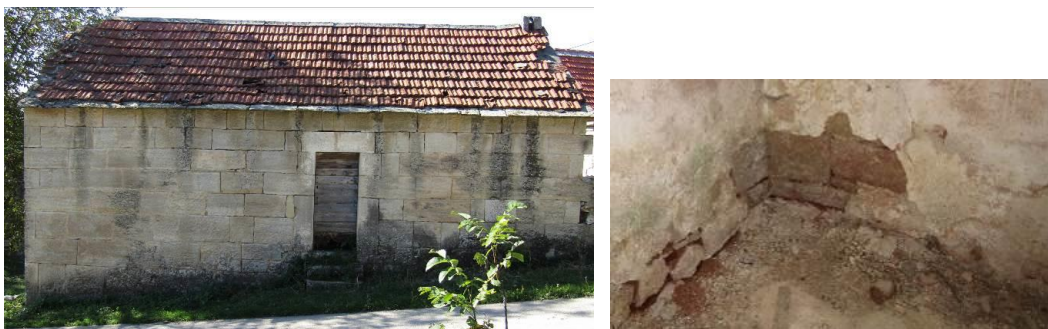
Figures 27-28. Degradation of the lower part of the northern facade (and foundation) of the house in Tomića Brig near Posušje, as a result of the capillary rise of rainwater and snow drifts, or the cycle of freezing near the ground; Due to the surface of the surrounding ground in a slope, surface water flow and flooding of the wall are present; The roof did not have a gutter, so rainwater fell from the roof onto the ground and bounced off onto the facade together with soil particles (left); detail of the interior of the house, as an illustration of the degradation (right), (photo: K. Šaravanja), [21]

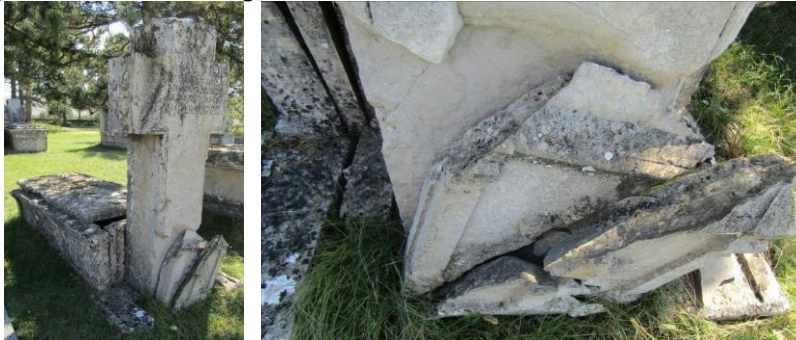
Figures 29-30. Different types of damage to tombstones made of freshwater limestone muljika at the cemetery in Livno, the lower part of which is destroyed by the action of frost, (photo: K. Šaravanja), [21]

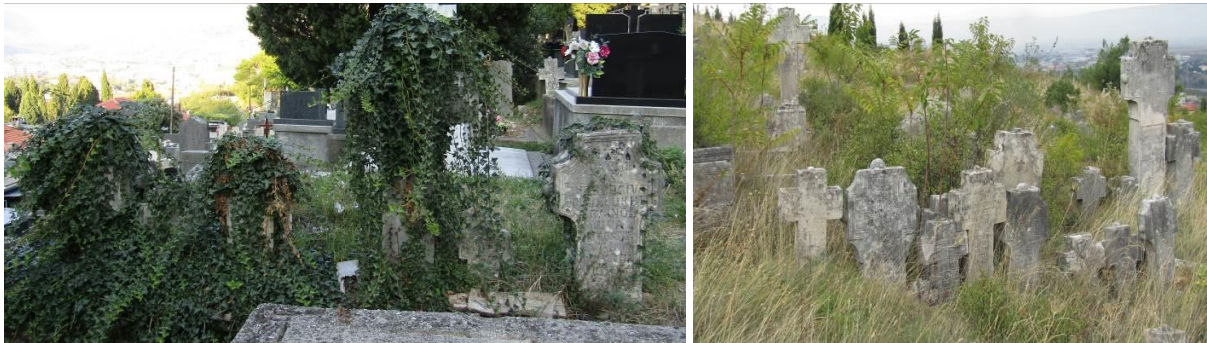
Figures 38-39. Ivy vegetation as an example of biological covering of tombstones in Šoinovac cemetery in Mostar (left); Tombstones in the old part of the Bjelušine cemetery in Mostar (right), which is neglected and overgrown with low wild vegetation, and a large number of monuments are overgrown with lichen and moss. During the war, all tall vegetation was removed from the cemetery area, which to a certain extent had previously protected the monuments from the sun and western winter winds, (photo: K. Šaravanja), [21]

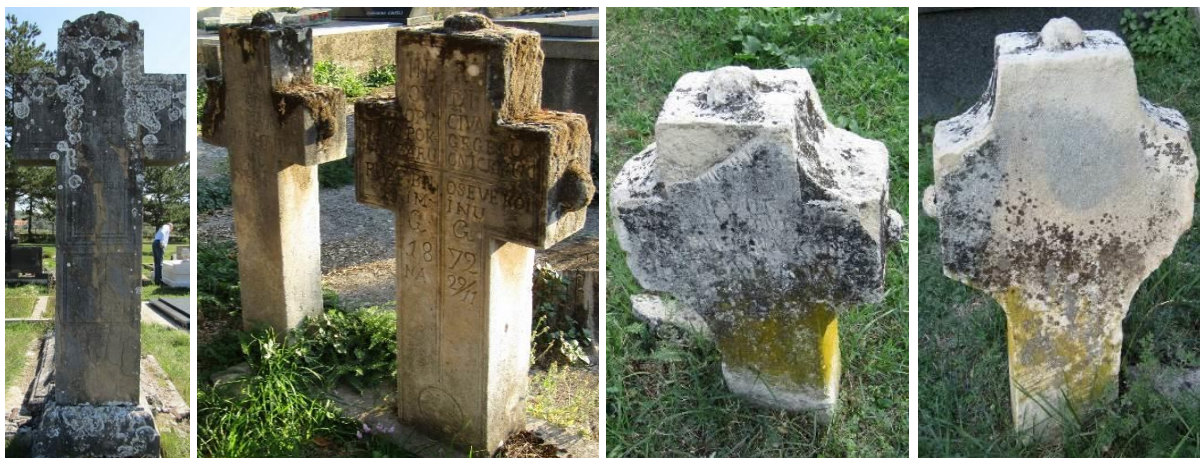
Figures 40-43. Covering of tombstones made of miljevina with biological cover in the cemetery of St. Ivo in Livno (left) and in the Šoinovac cemetery in Mostar (other 3 figures); Biological covering (lichens, moss, fungi,...) use stone as habitat and/or food, (photo: K. Šaravanja), [21]

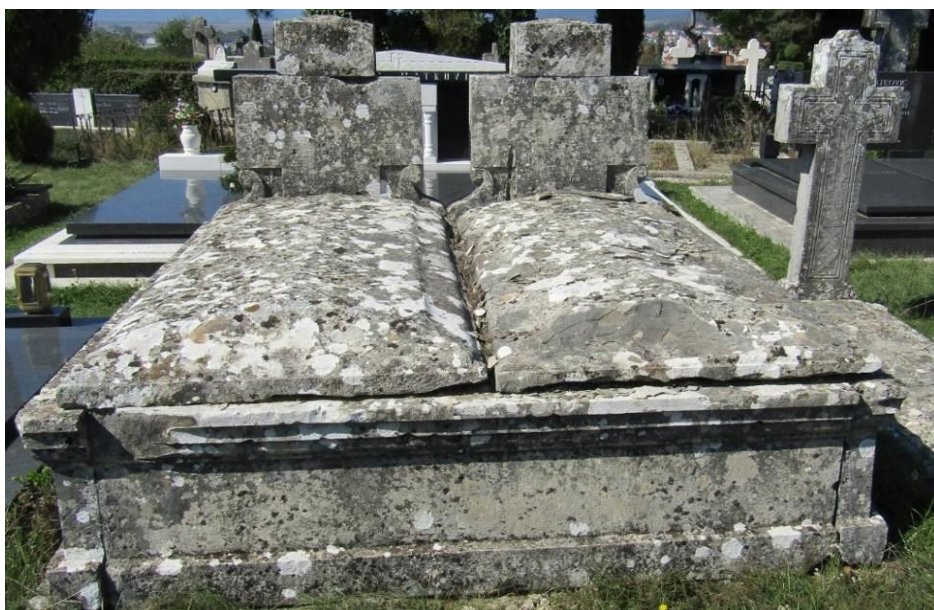
Figure 44. Lichens and mosses covering tombstones in the cemetery of St. Ivo in Livno, (photo: K. Šaravanja), [21]

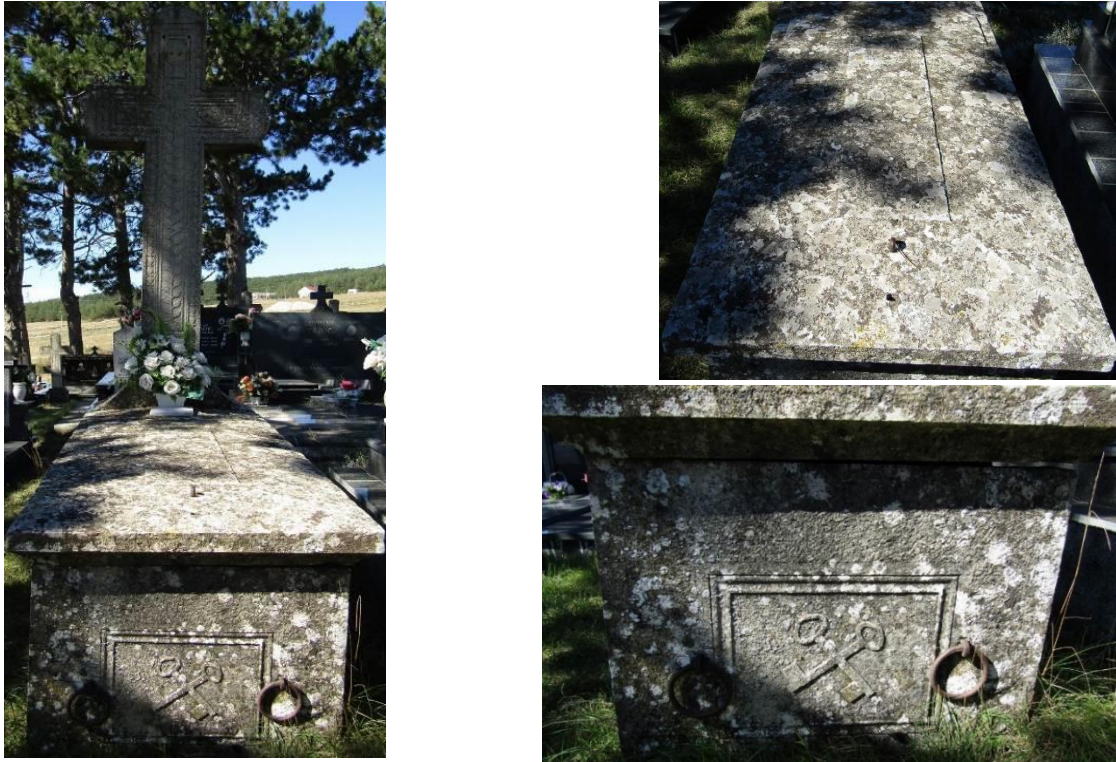
Figures 45-47. Lichens and mosses covering tombstones made of miljevina in the Kolo cemetery near Tomislavgrad. The cover plate made of freshwater limestone, 200 cm long, 50-80 cm wide, and about 5 cm thick, is interesting as a certain proof of its stability in harsher climatic conditions. Engraved motifs are very rarely damaged. It should also be borne in mind that the cemeteries used to be forested with pines and oaks, which today are present much less or not at all, and this influence of trees on the stone of the monuments is very difficult to retroactively analyze, (photo: K. Šaravanja), [21]

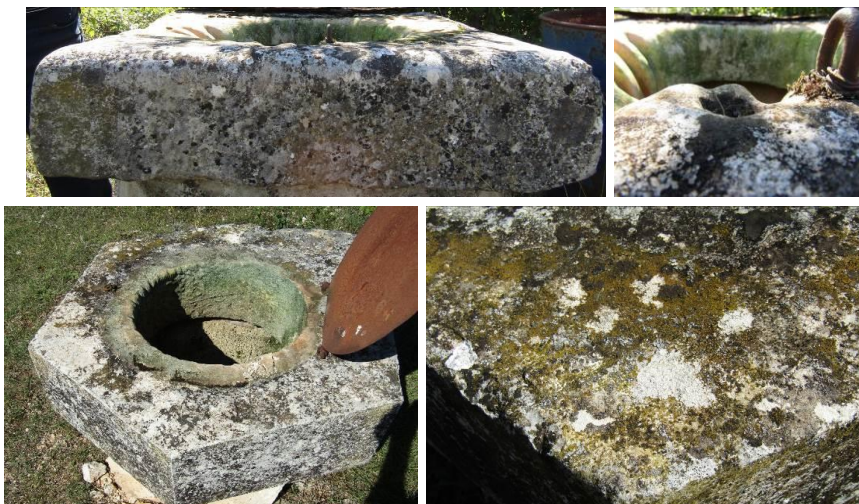
Figures 48-51. The crowns of stone cisterns made of (Posušje) miljevina covered with lichen and moss at the location of the Kovači hamlet, southwest of Posušje, with details, (photo: K. Šaravanja), [21]

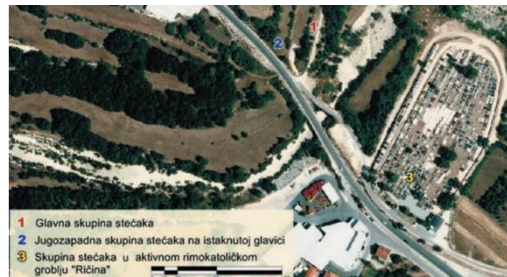
Figure 52. Part of an orthophoto with the positions of 3 groups of stećak tombstones on Ričina near Posušje, [31]

A visual inspection of the surface of the stećak tombstones at the Ričina site near Posušje, which is not too far from the stećak tombstones from the Crljivica site, shows a similar wide range of microorganisms, which should be investigated. Still, the general condition of stećak tombstones made of *(Posušje) miljevina* in Ričina near Posušje is relatively good, bearing in mind the harsh climate conditions to which they were exposed for hundreds of years, which indicates not only the resistance to frost, but even more broadly indicates the overall durability/stability of this and other freshwater limestones.

Figures 53-57. Seven stećak tombstones of the main group of stećak tombstones, marked "1" in Figure 52 (figures above) and two significant and preserved gabled stećak tombstones as part of the modern cemetery, marked "3" in Figure 52 (figures below) made of *(Posušje) miljevina* on Ričina near Posušje; A wide range of microorganisms (lichens, bacteria, cyanobacteria and fungi) is visible on the stećak tombstones, (photo: K. Šaravanja), [21]

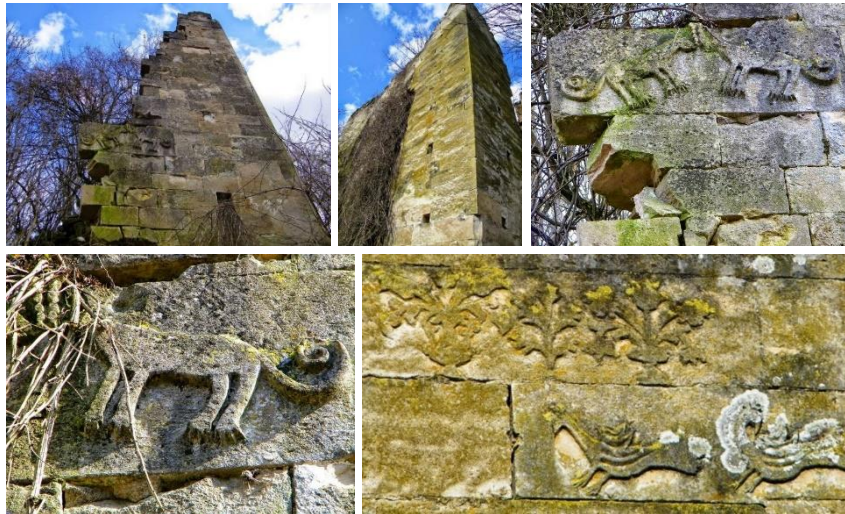
Figures 58-62. A good example of preservation of freshwater limestones miljevina in the remains of the Čengić bays' tower in the village of Rataji near Miljevina in eastern Bosnia. In addition to the patina, the presence of biological covering in the form of moss, lichens and fungi is noticeable, (photo: Zaim Bešović, 2015)
