UTJECAJ VODOTOKA NA SIGURNOST MOSTOVA

Neven Kuspilić, Ph.D.

Gordon Gilja, Ph.D.

INFLUENCE OF WATERCOURSE FLOW ON BRIDGE SAFETY

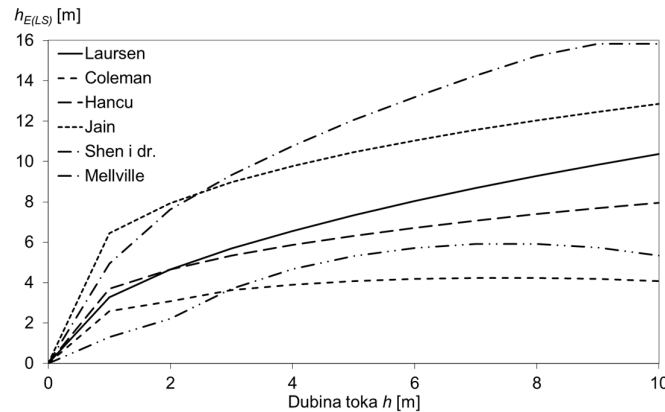
From this it can be concluded that the reliance on results of theoretical equations is very unreliable and only measurements of actual depths of bridge pier scour within systematic monitoring can be the basis to ensure safety of bridges.

Figure 1. The $h_{E(LS)}$ dependency on the example of the Jakuševac bridge, adapted by courtesy of [19]1

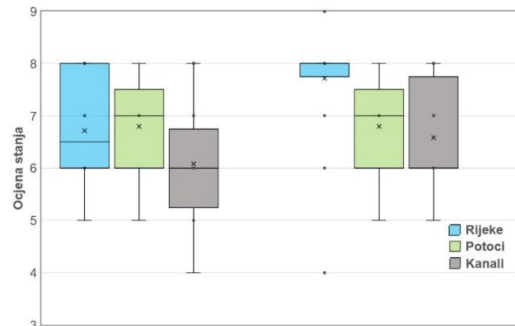
Figure 2. Box-like diagram of condition ratings: a) beds (left); b) structures (right) 2

If bridges are considered on the basis of watercourse group, it is evident that channels are in the best condition in terms of structure, with an average rating of 7.6, while streams and rivers have slightly lower ratings (6.8 and 6.6), which is expected because bridges over channels rarely have piers in water, and they are most often single-span RC structures. Channels also have high average ratings of the condition of bed (6.7), which is slightly lower than streams (6.8). Rivers are rated lowest in this category too (6.1). It is evident that the range of ratings for the condition of bed is largest for channels, while the range for rivers and streams is equal with greater interquartile range. The range of ratings of the condition of structure is largest for rivers, but with a very small interquartile range, while for streams and channels the total range is equal with a slightly greater interquartile range for channels.

The condition of bed and the condition of structure are in a positive correlation, i.e. if the rating assigned to the underwater condition of a structure deviates from the rating of the bed at the level of the analyzed three classes, the deviation is not more than 1 rating in the positive or negative direction. The opposite is also true if considering classes of ratings assigned to the condition of structure. Thus, of the bridges with the condition of bed rated as very good (≥ 8), only the Krk bridge have a lower rating of the structure, that is 6. On the Krk bridge, scattered damage is observed on structural elements - under the bracing on the mainland side and on the foundation and arch on the Krk side. Of the bridges with the condition of bed rated as good (6 and 7) only the Orljava bridge has a lower rating of structure, that is 5. Damage is observed on piles of two piers of this bridge, i.e. holes between 15 cm and 20 cm in width and depth. The bridges with the condition of bed rated as poor (4 and 5) are the larger bridges on the Sava and Drava rivers, as well as the bridge over the Kupčina River and the bridge over the Lateral Channel. While the condition of structure of the latter two bridges corresponds to the condition of bed, the state of structure under water of the larger bridges over Save and Drava is better (rating 6). For bridges on the Drava River, it is the operation of the hydroelectric power plant that causes sudden changes in the water regime and consequential registered global lowering of the bed in relation to the design state. For the bridge with the poorest bed condition rating (4), Ivanja Reka, the adverse condition of the bed is the consequence of local erosion around the rip-rap that protects the pier against local erosion. The rip-rap significantly narrows the flow profile of the Sava River and causes deep scour holes to occur immediately next to the rip-rap, undermining it and thus causing rock to fall into the holes [30].
