Analysis of bus station pavement structure condition in the City of Rijeka

Pregledni rad / Review paper
Primljen/Received: 6. 4. 2018.;
Prihvaćen/Accepted: 25. 5. 2018

Abstract: Road network condition deteriorates over time because of the climatic and meteorological conditions, traffic loading and insufficient maintenance. Bus stations on urban road network are especially exposed to premature damage appearance due to specific loading conditions. In this paper an analysis done at the chosen bus stations in Rijeka city is presented. Different parameters were measured and analysed and suggestions for maintenance of analysed pavements are defined.

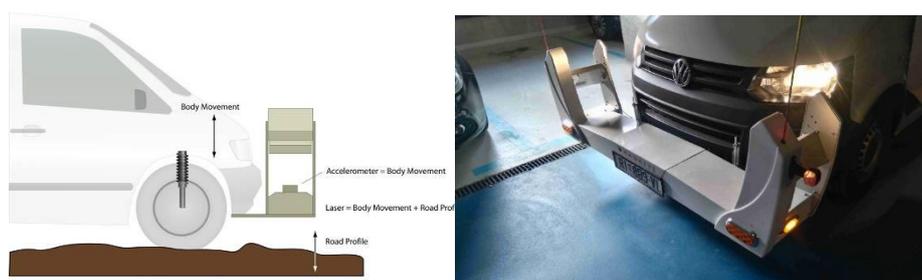
Figure 2. A view of the measurement vehicle Hawkeye 2000

Roughness measurements were conducted using vehicle-installed laser profilometer system Hawkeye 2000 (Figure 2).

The technical parameter of roughness (IRI) was measured along the right and left wheelpath on the selected locations. For the purposes of the paper, the mean value of roughness index IRI was analysed. The measured values and condition assessment in terms of evenness are shown in Table 2.
