## Load testing of the Svilaj interstate bridge

**Abstract:** The paper presents static and dynamic load testing of the Svilaj interstate bridge over the Sava River. In addition to presenting the basic structural elements of the bridge, the paper briefly describes the testing method, provides the basic characteristics of the equipment used for testing, and presents some of the results of the conducted testing along with an analysis and comparison of the measured parameters. At the end of the paper, the conclusion explains that a high level of agreement between the measured parameters was determined and the performance of the structure was verified.

This paper presents the results of load testing conducted on the Svilaj interstate bridge over the Sava River, which is an integral part of the international Pan-European road corridor Vc Budapest - Beli Manastir - Osijek - Sarajevo - Ploče (Figure 1). Corridor Vc is part of the European highway network, designated as E-73, which connects northern Europe with the Adriatic and forms the backbone of road infrastructure in the eastern part of Croatia. The bridge over the Sava River is also a contact point of the highway networks of the Re

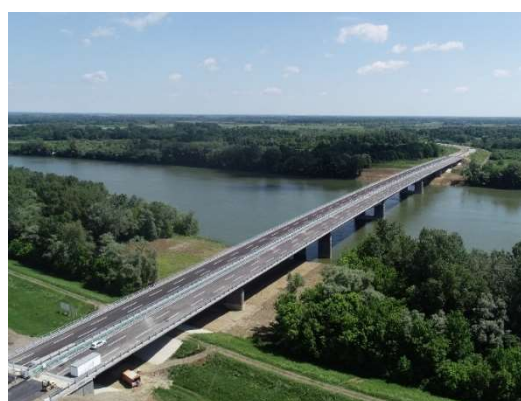
Figure 2. - Svilaj bridge

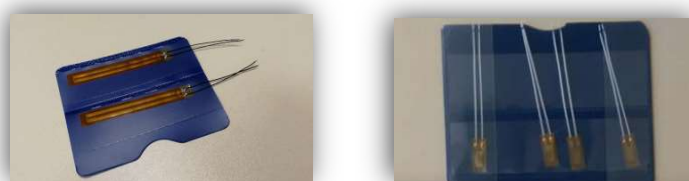
For the measurement of strains in concrete, strain gauges manufactured by HBM, type K-LY41 1-15-120-0, were used, while the strains in steel were measured using HBM strain gauges type K-LY41 6/120 (Figure 10).

Figure 10. - Strain gauges for concrete (left) and steel (right)

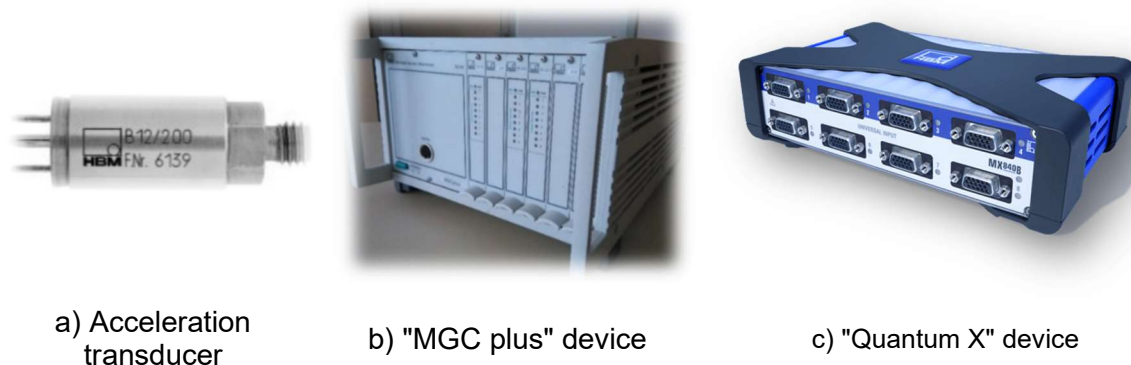
Acceleration was measured using an acceleration transducer, namely an HBM uniaxial accelerometer, type B12/500 (Figure 11a). The measured values were collected using the

*MGC plus* (Figure 11b) and *Quantum X* (Figure 11c) systems, and were processed with the Catman AP software package. The maximum number of measurement points at one measurement location was 24 (Figure 12).

Figure 11. - Measurement equipment used

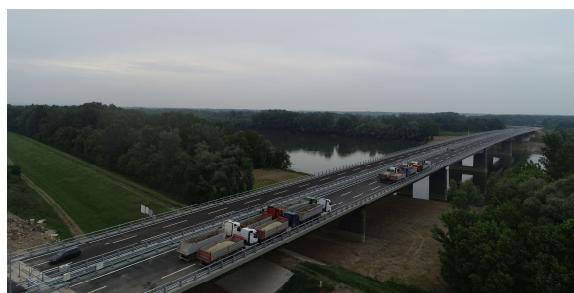
Static tests (Figures 13 and 15) were carried out according to the loading schemes presented in Chapter 3. The test results for vertical displacements and strains, taken from the Test Report [8], will be presented in the following text.

Figure 13. - Placing the load in position for static testing

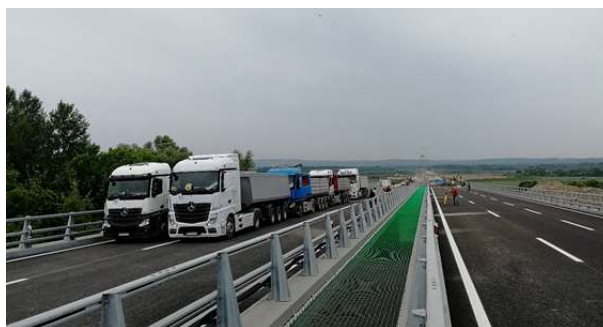
Figure 15. - Load in the position for static testing

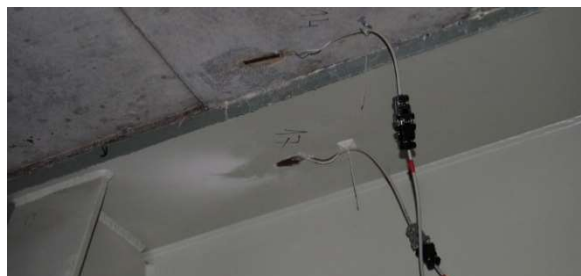
Note: The strain gauge at position CGL (steel-top-left) was not operational due to damage to the test cable. The strain gauges were connected to the measuring device and computer with special connectors (Figure 19).

Figure 19. - Strain gauges for measuring strains on concrete and steel structures

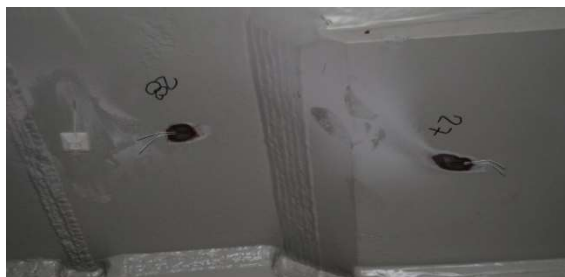
Figure 29. - Strain gauges for measuring strains for the change in flange thickness
